## **FY08 3<sup>rd</sup> Quarter Construction Contractor Safety Seminar**

**April 8, 2008 Meeting Minutes**

# ***QUARTERLY CONSTRUCTION SAFETY SEMINAR***

## **SNL FACILITIES**

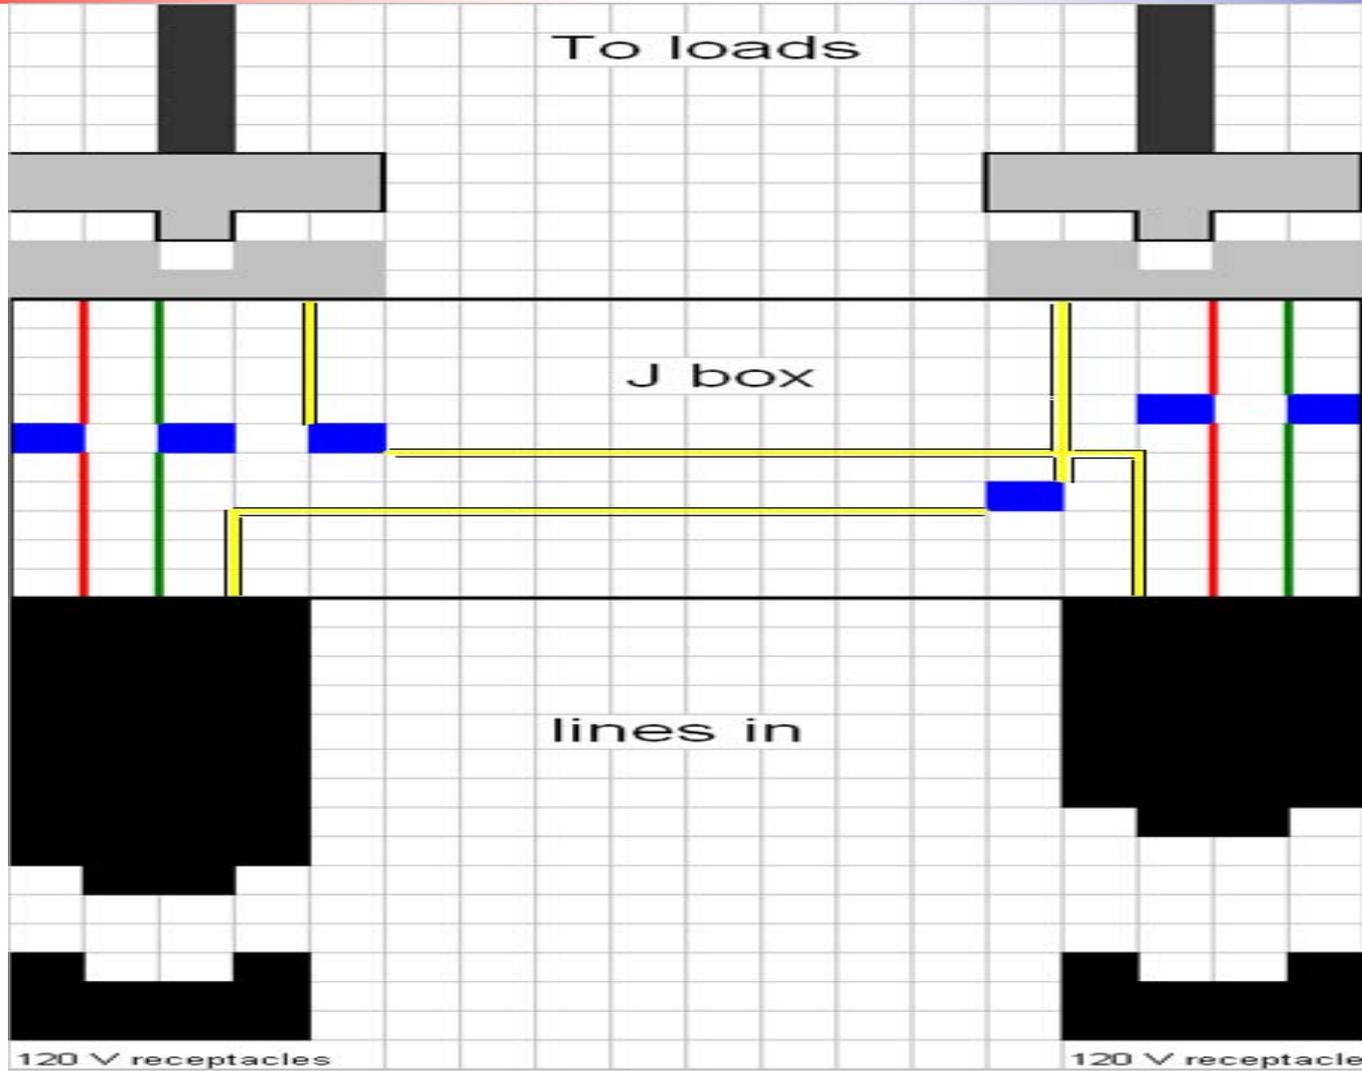
# Electrical Cord Wiring

120 V receptacles

120 V receptacle

- The impacted line employee plugged one cord into a wall receptacle and the employee heard "fan circuit 1" turn on. The worker then plugged in a second cord feeding "fan circuit 2" and did not hear any additional fans turning on. While walking the third cord to a third wall receptacle, the worker's finger simultaneously made contact with the neutral and ground pins of the cord end and received a shock. Investigation identified that during the cord installation activity, the Electrical Construction Contract electrician crossed neutrals of the cords to fan 2 and the lights.

- Because of the crossed neutrals, the neutral connected to "fan circuit 2" was wired to the plug (lighting) the employee was holding. When the employee's finger touched the neutral and ground terminals on the plug, the circuit to "fan circuit 2" was completed, and the employee was shocked.
- A Facilities Management and Operations Center (FMOC) electrician was contacted for diagnostics and testing. The electrician corrected the problem and verified that all circuits are now in a safe configuration.
- The line employee was taken to medical for evaluation and released with no restrictions.

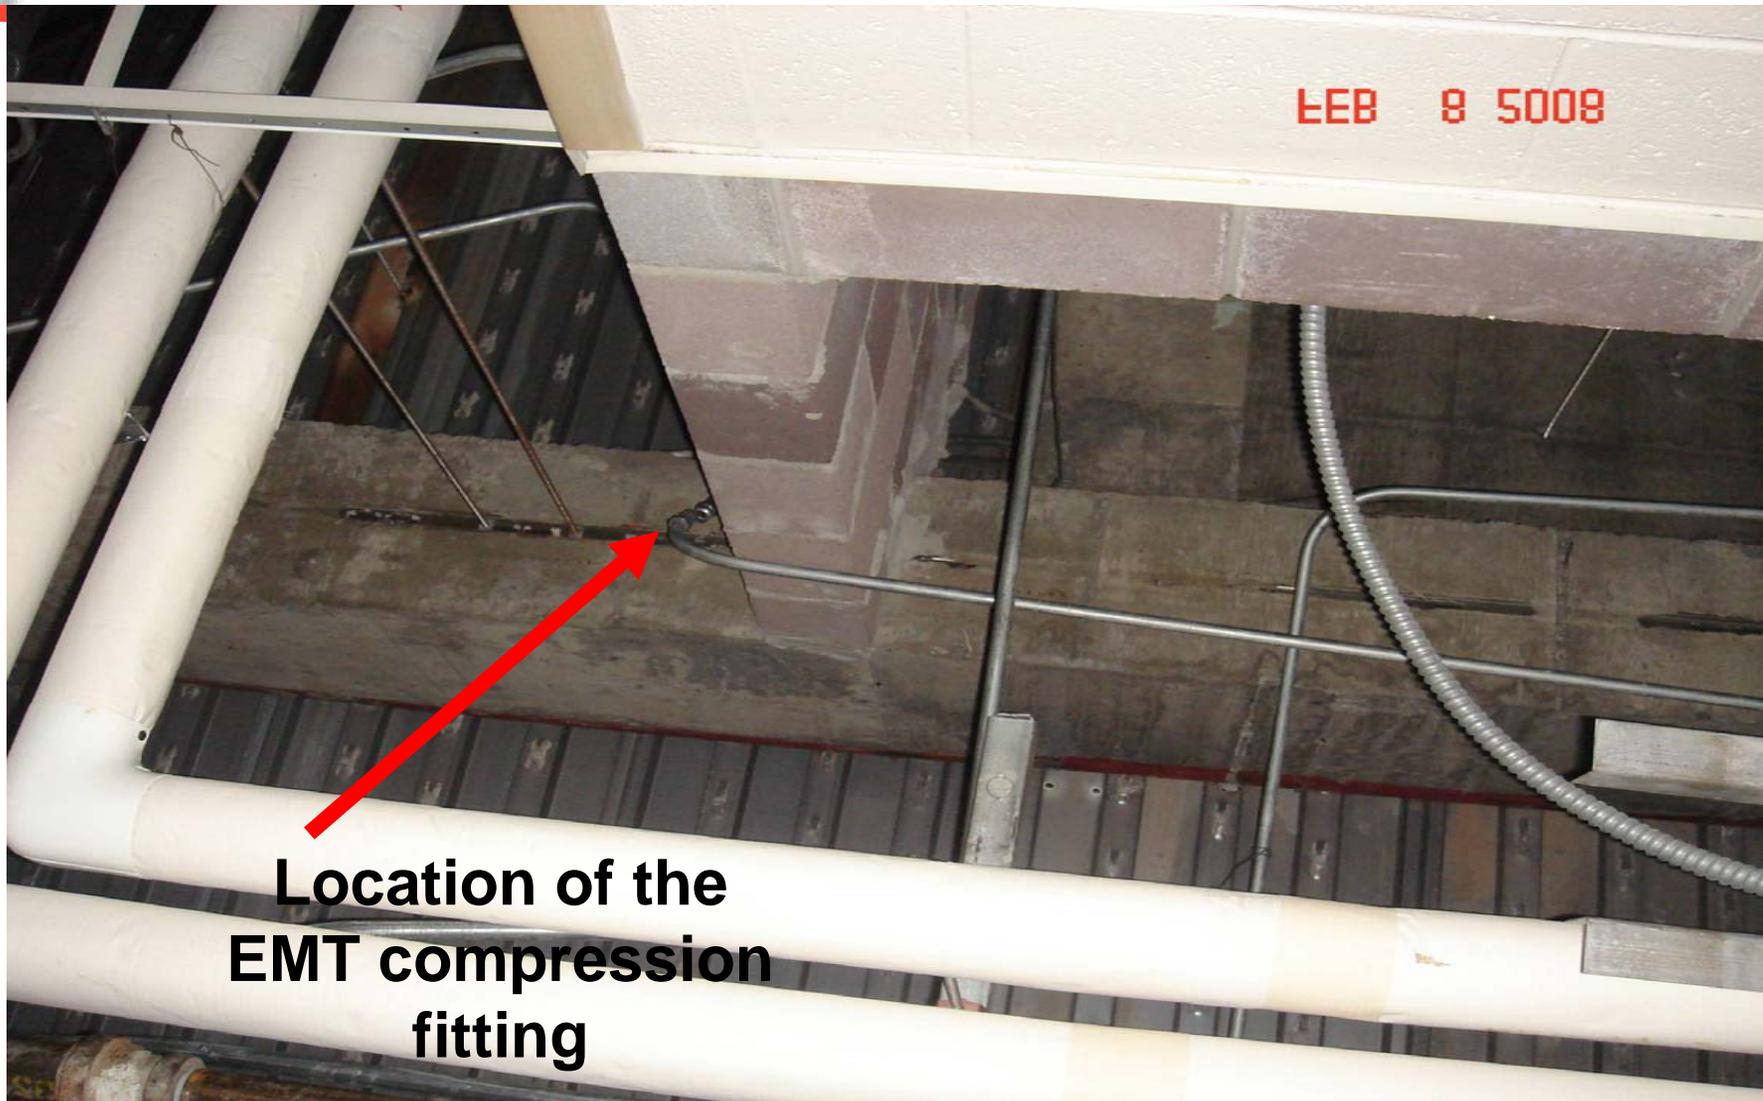
# Picture

**Location of the  
EMT compression  
fitting**

- While installing the plastic sheeting the worker pulled a conduit away from a small section of block wall to place the plastic material behind the conduit. The conduit pulled apart at a coupling and damaged the conductors resulting in a 120V shock to the worker.
- The worker was transported to SNL Medical by a co-worker for medical evaluation and was released that same day with no restrictions.

- A project restart plan was developed that will include an updated utility plan for the project. The utility plan will include: drawings detailing temporary power for the building during decon and demolition operations.
- Abatement Contractor will update their CSSP to include a requirement for a walkdown with the PM and Utility Contractors (electrical and mechanical as appropriate) for abatement projects that require utilities in the abatement containment area to remain in service/energized.

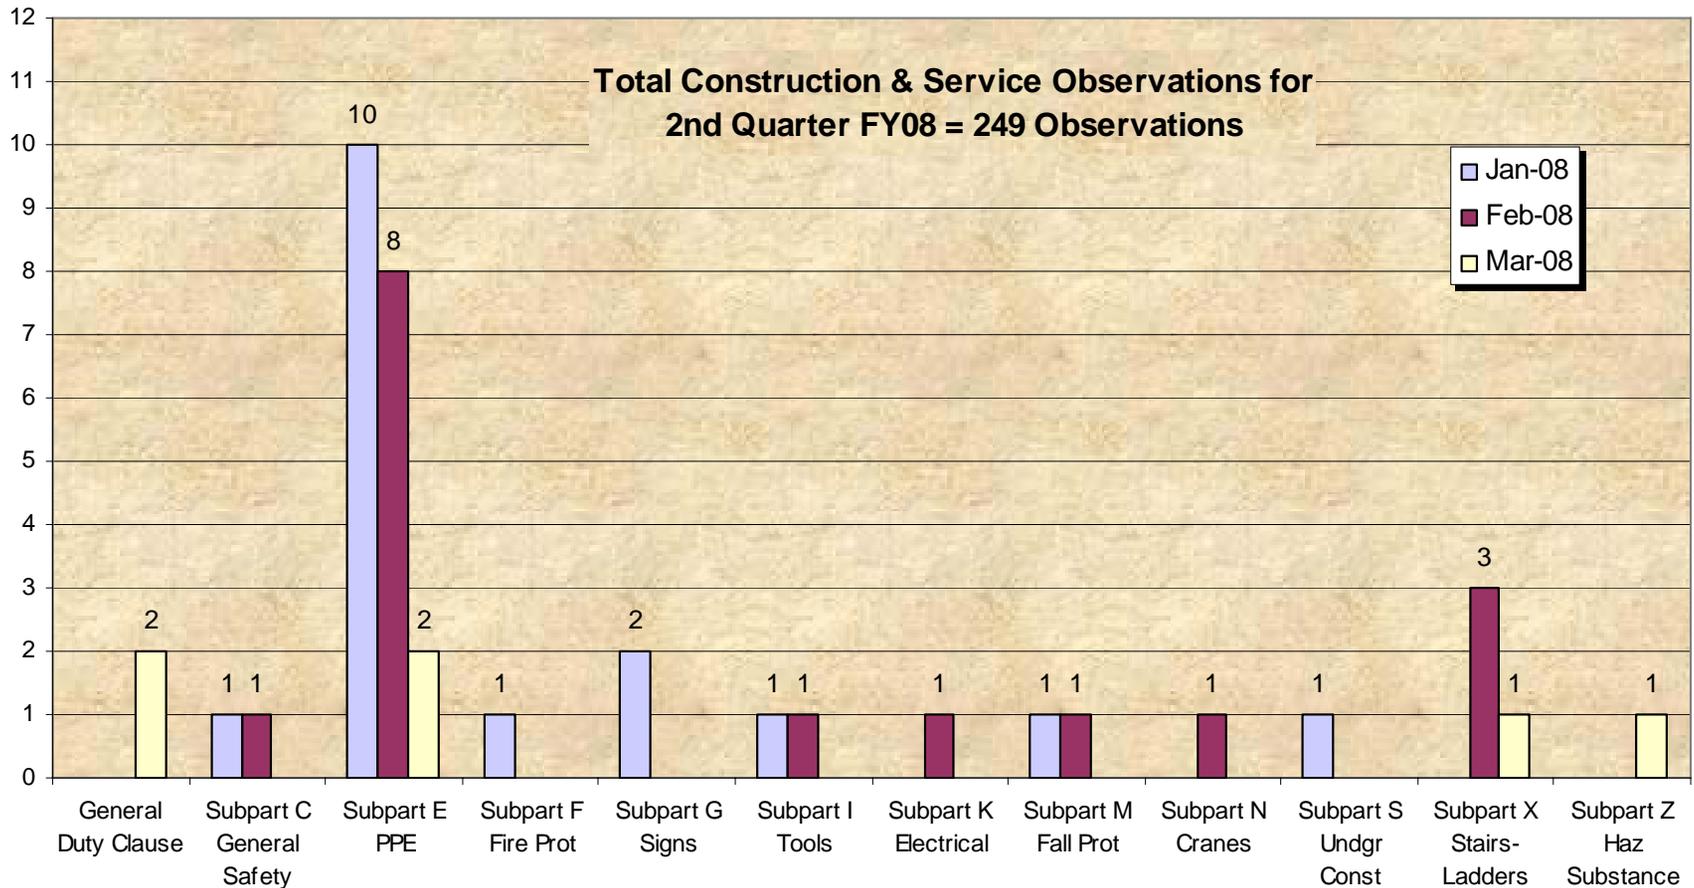
# Non-compliant Observations OSHA 1926 for Jan – Mar 2008

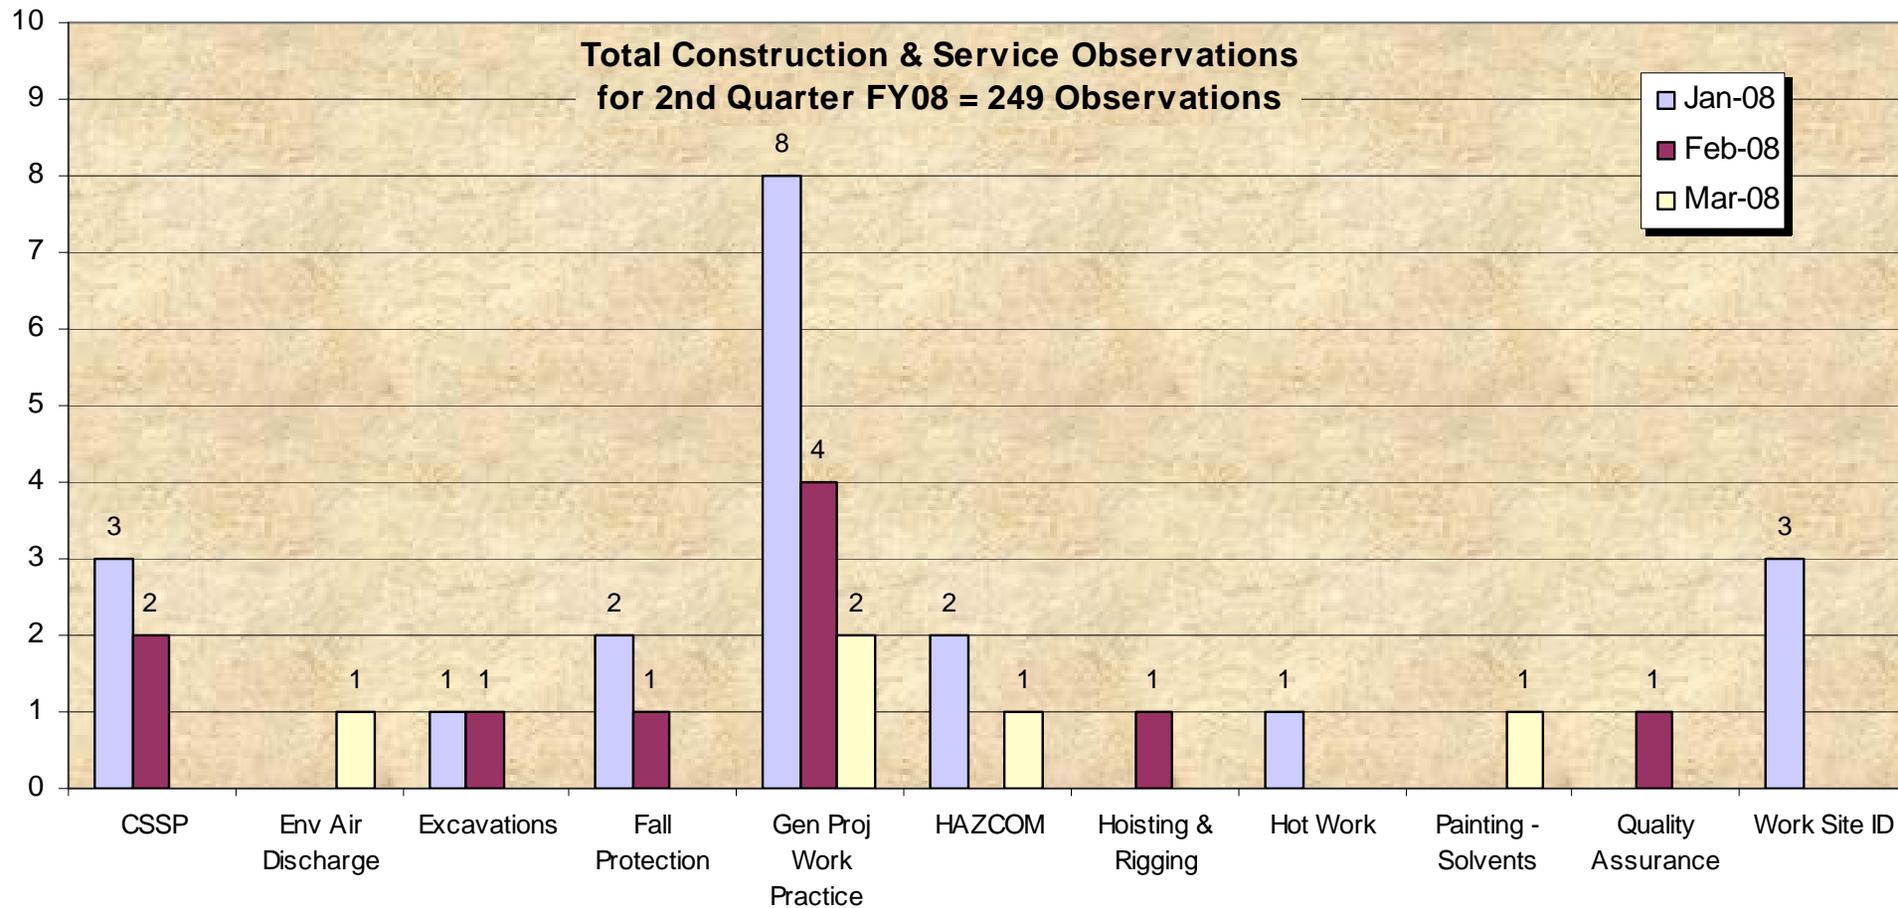
# Non-compliant Observations 01065 Spec for Jan – Mar 2008

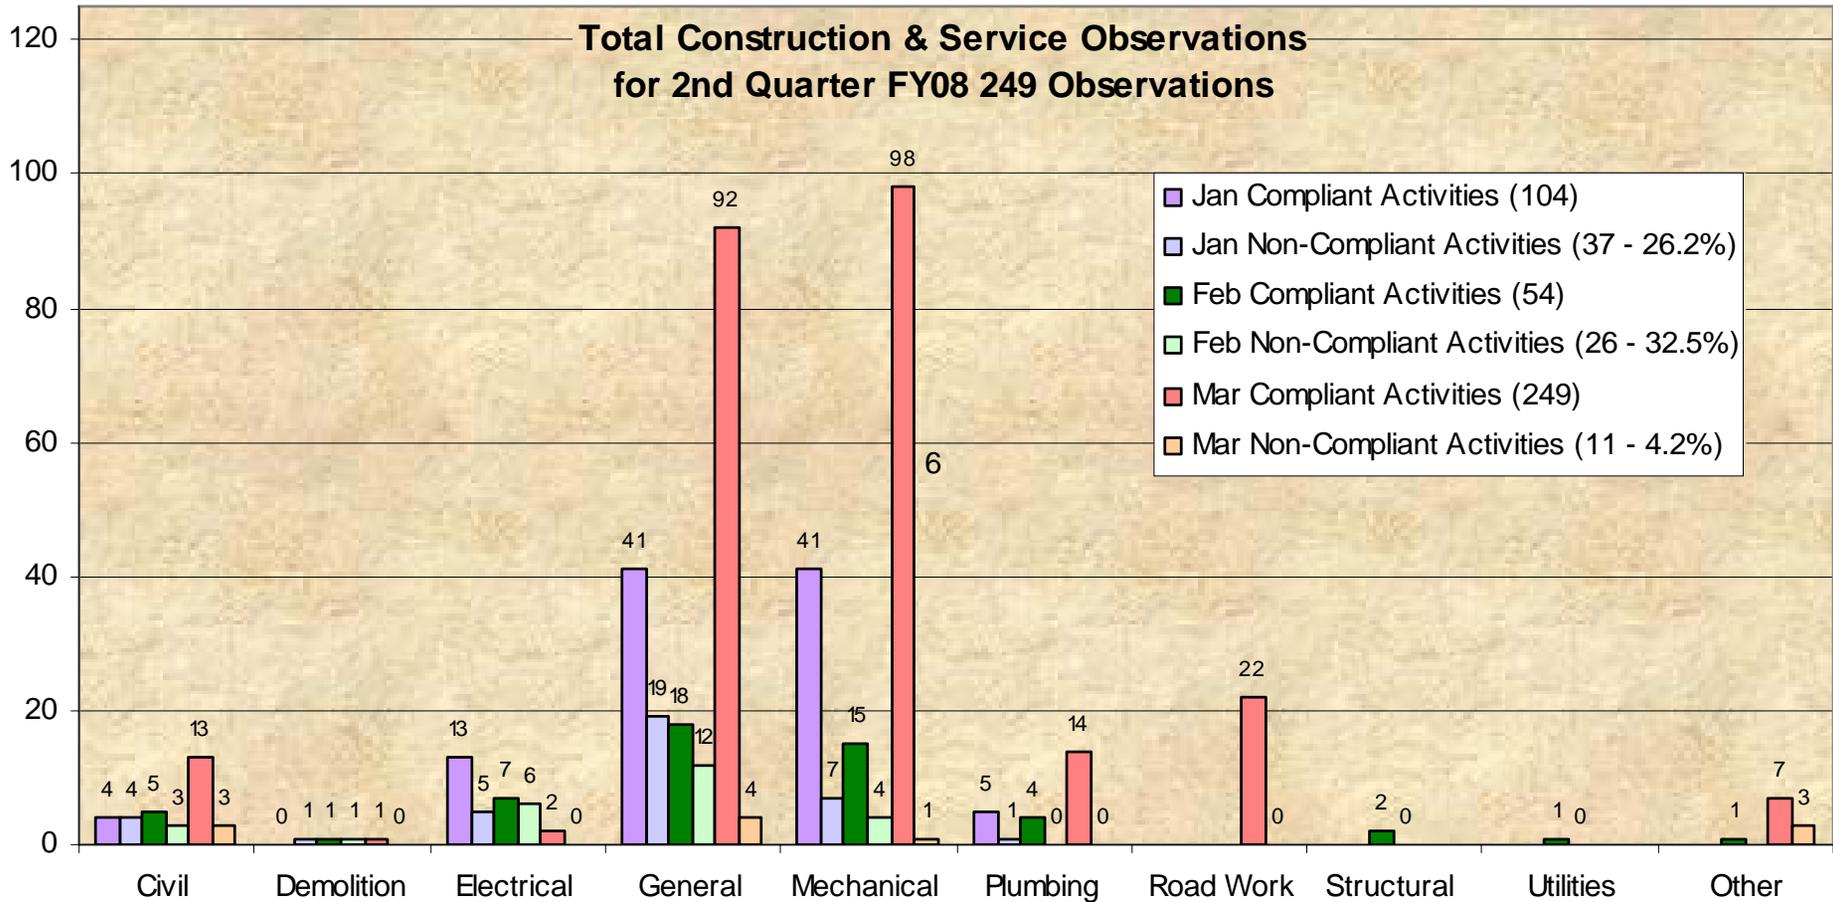
# Compliant vs. Non-compliant Observations by Discipline Jan – Mar 2008

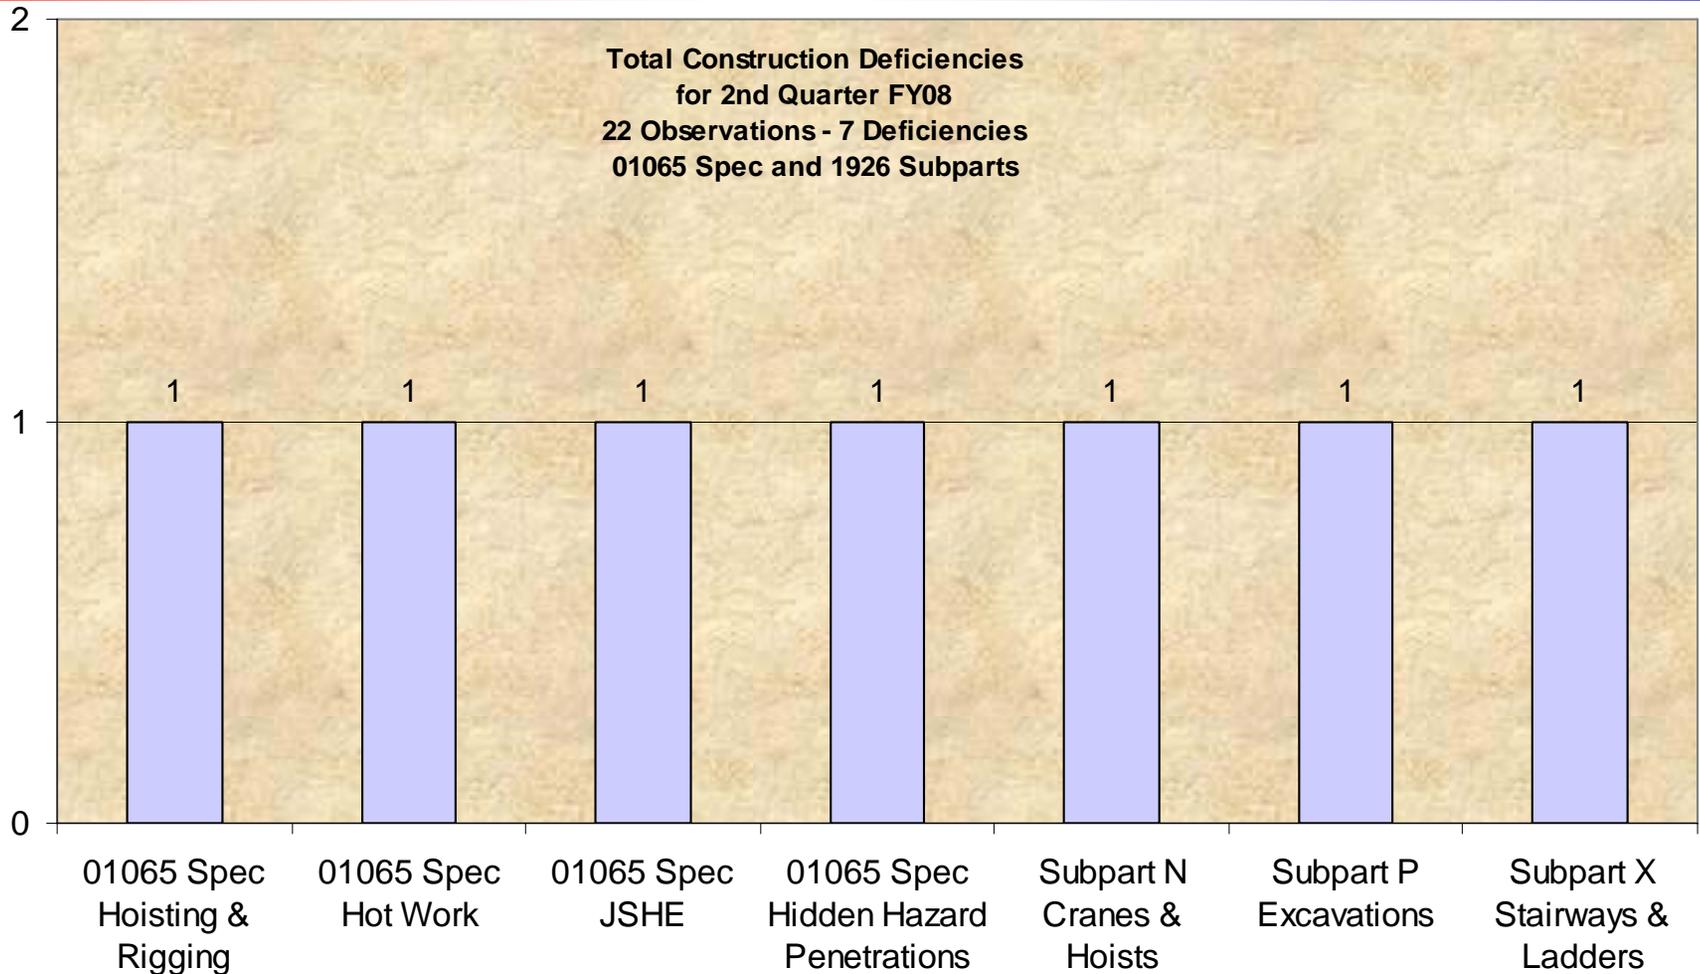
# Construction Observations

## Jan – Mar 2008

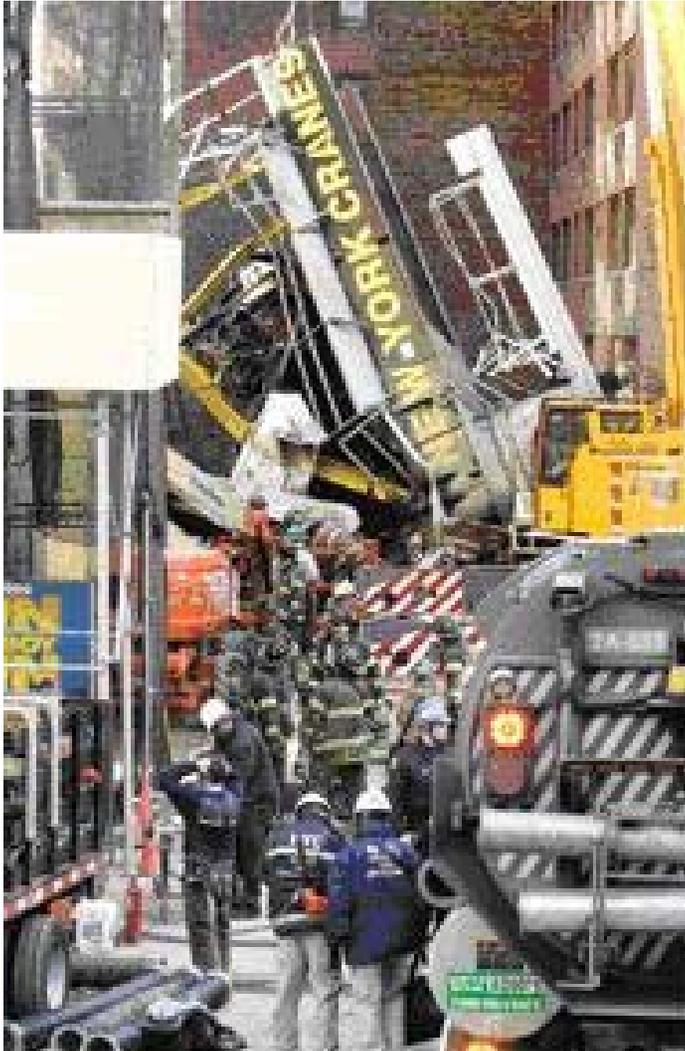
Area around the fallen crane was cordoned off as rescuers searched for missing persons in the rubble of a building.

- Expert witness believes that the sling may be the cause. Over half of the cases focus on sling failures, he says. “The number-one failure of nylon slings is cutting around edges of loads.” “It’s very, very important to protect against cutting.” Cutting that occurs on a previous lift would require immediate disposal, he says.

- “Slings shall be padded or protected from the sharp edges of their loads,” according to OSHA’s sling regulation. The expert witness notes that operators often use makeshift materials, even worn-out slings, for the purpose. “I’ve even seen fire hoses used.” “When you get to heavier loads or critical loads you need specially designed edge protectors.” Other problems with slings, especially synthetic ones, include sun bleaching, heat damage and abrasion.

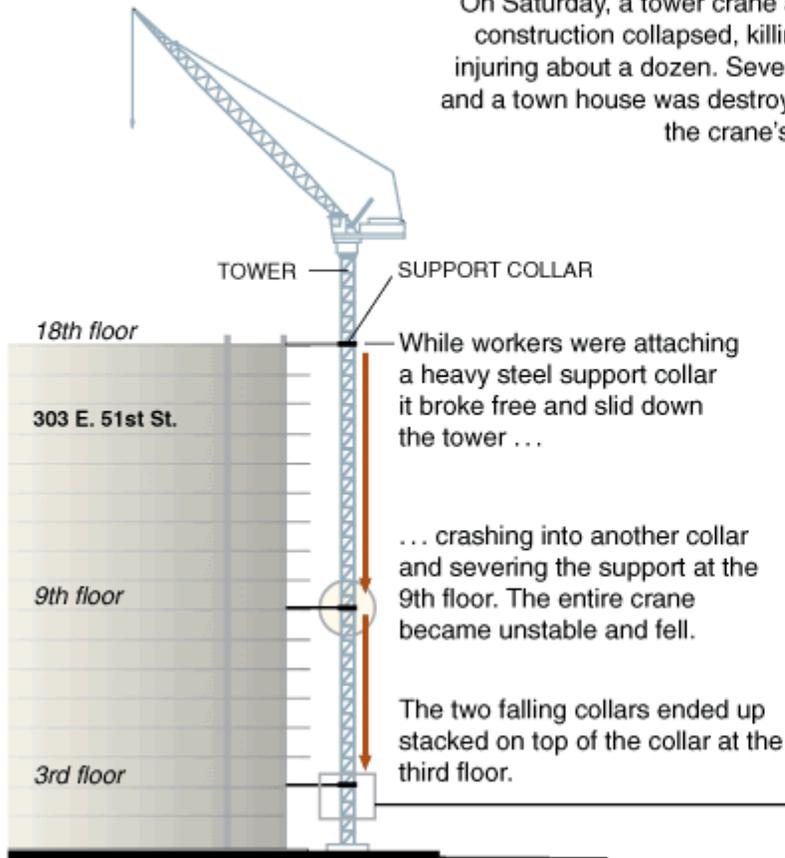
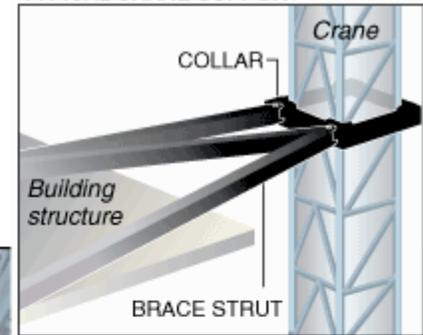
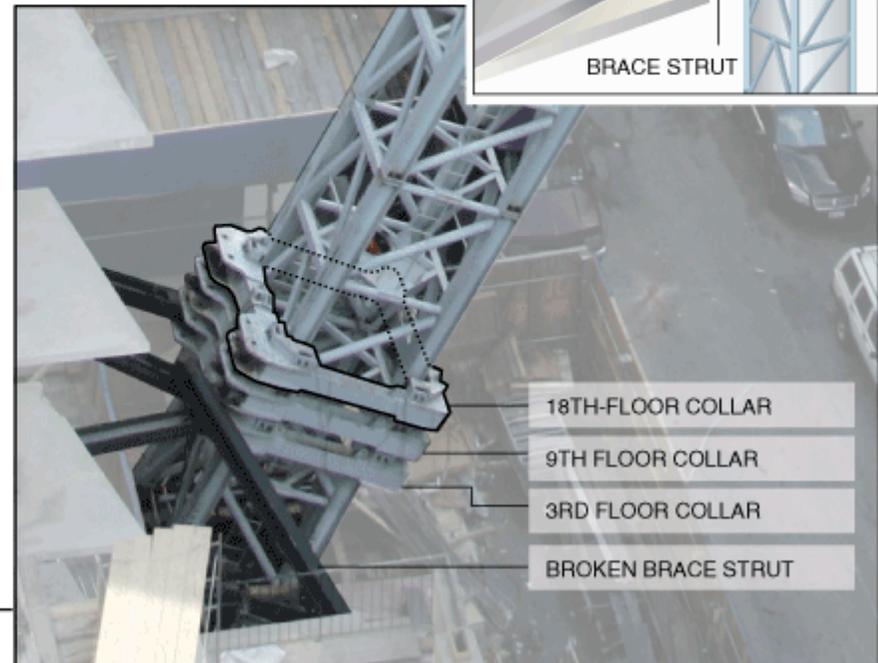
TYPICAL CRANE SUPPORT

On Saturday, a tower crane attached to a building under construction collapsed, killing at least four people and injuring about a dozen. Several buildings were damaged, and a town house was destroyed. The details of what led to the crane's collapse:

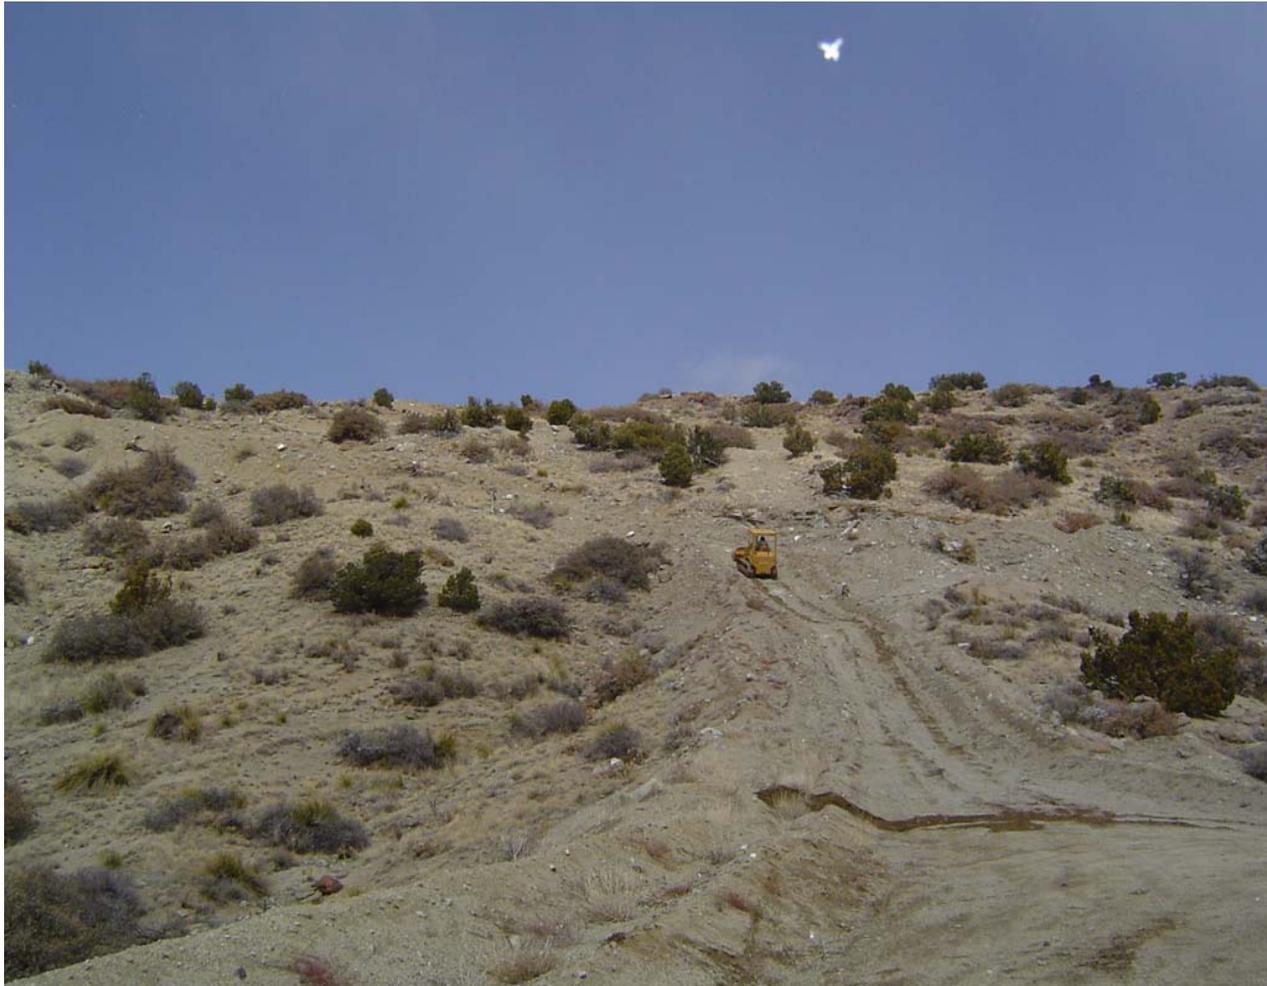
# Material Transport

William presented a summary of the first of a kind task involving ascending up the side of Manzano Mountain with a bull dozer pulling a piece of equipment, pulling cable and putting a cable raceway into an air shaft. All previous work had been done by helicopter.

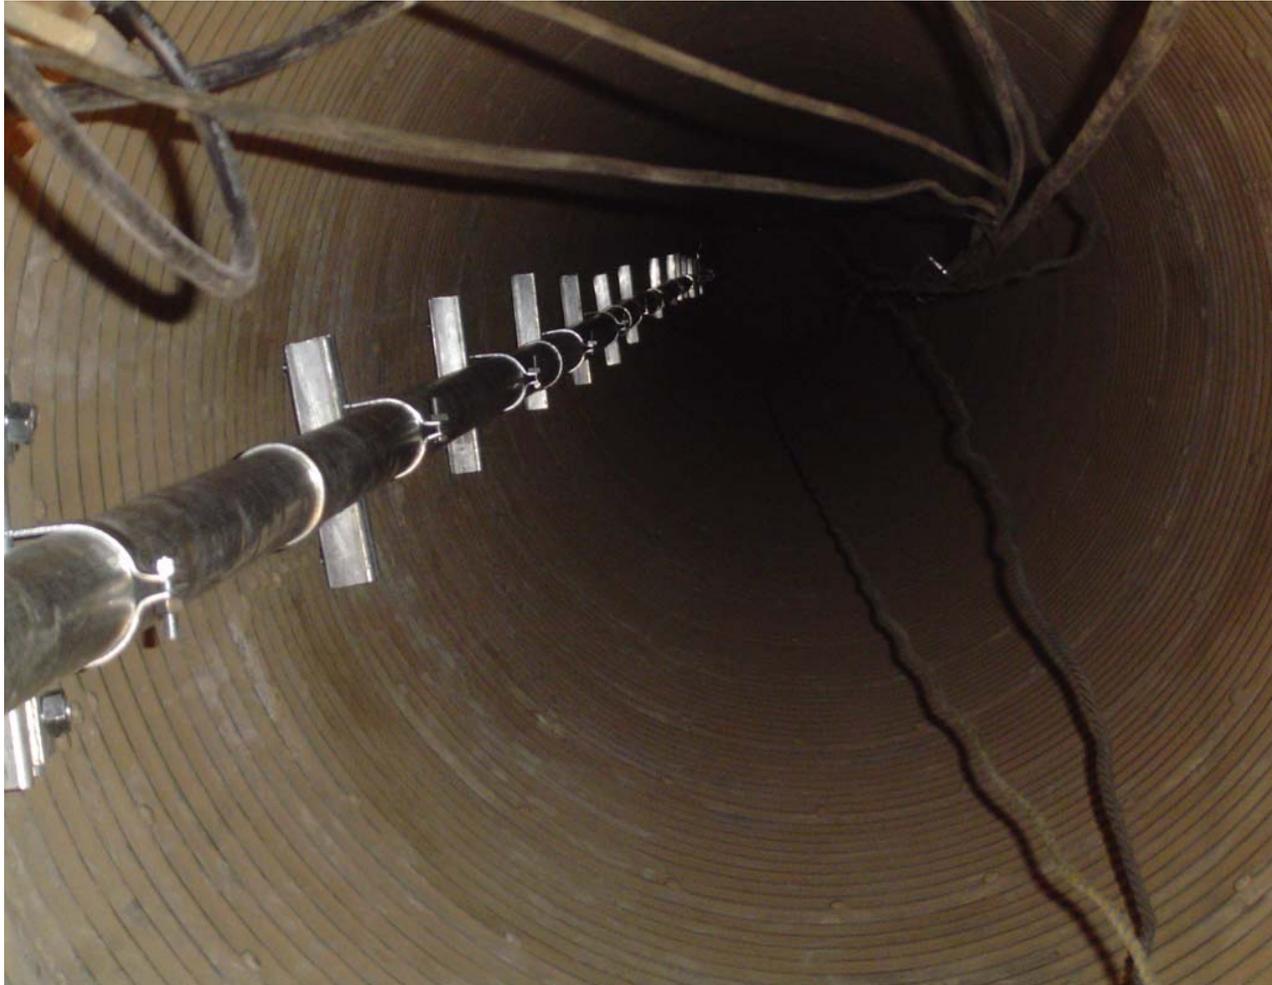
# Raceway

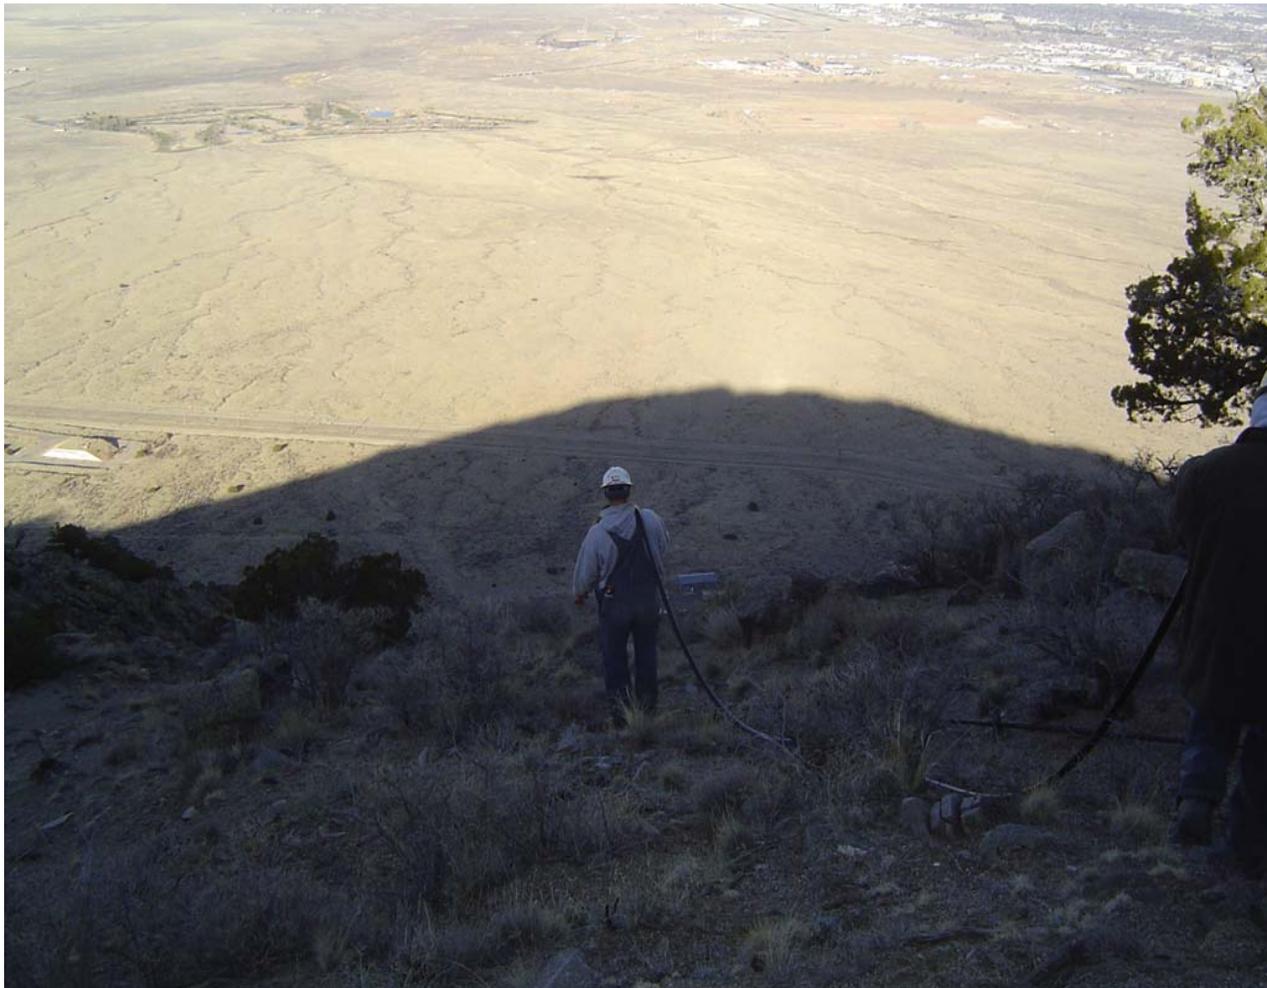
# Cable Pull
