## **FY08 4<sup>th</sup> Quarter Construction Contractor Safety Seminar**

**July 8, 2008 Meeting Minutes**

# ***QUARTERLY CONSTRUCTION SAFETY SEMINAR***

**4<sup>th</sup> Quarter FY08**

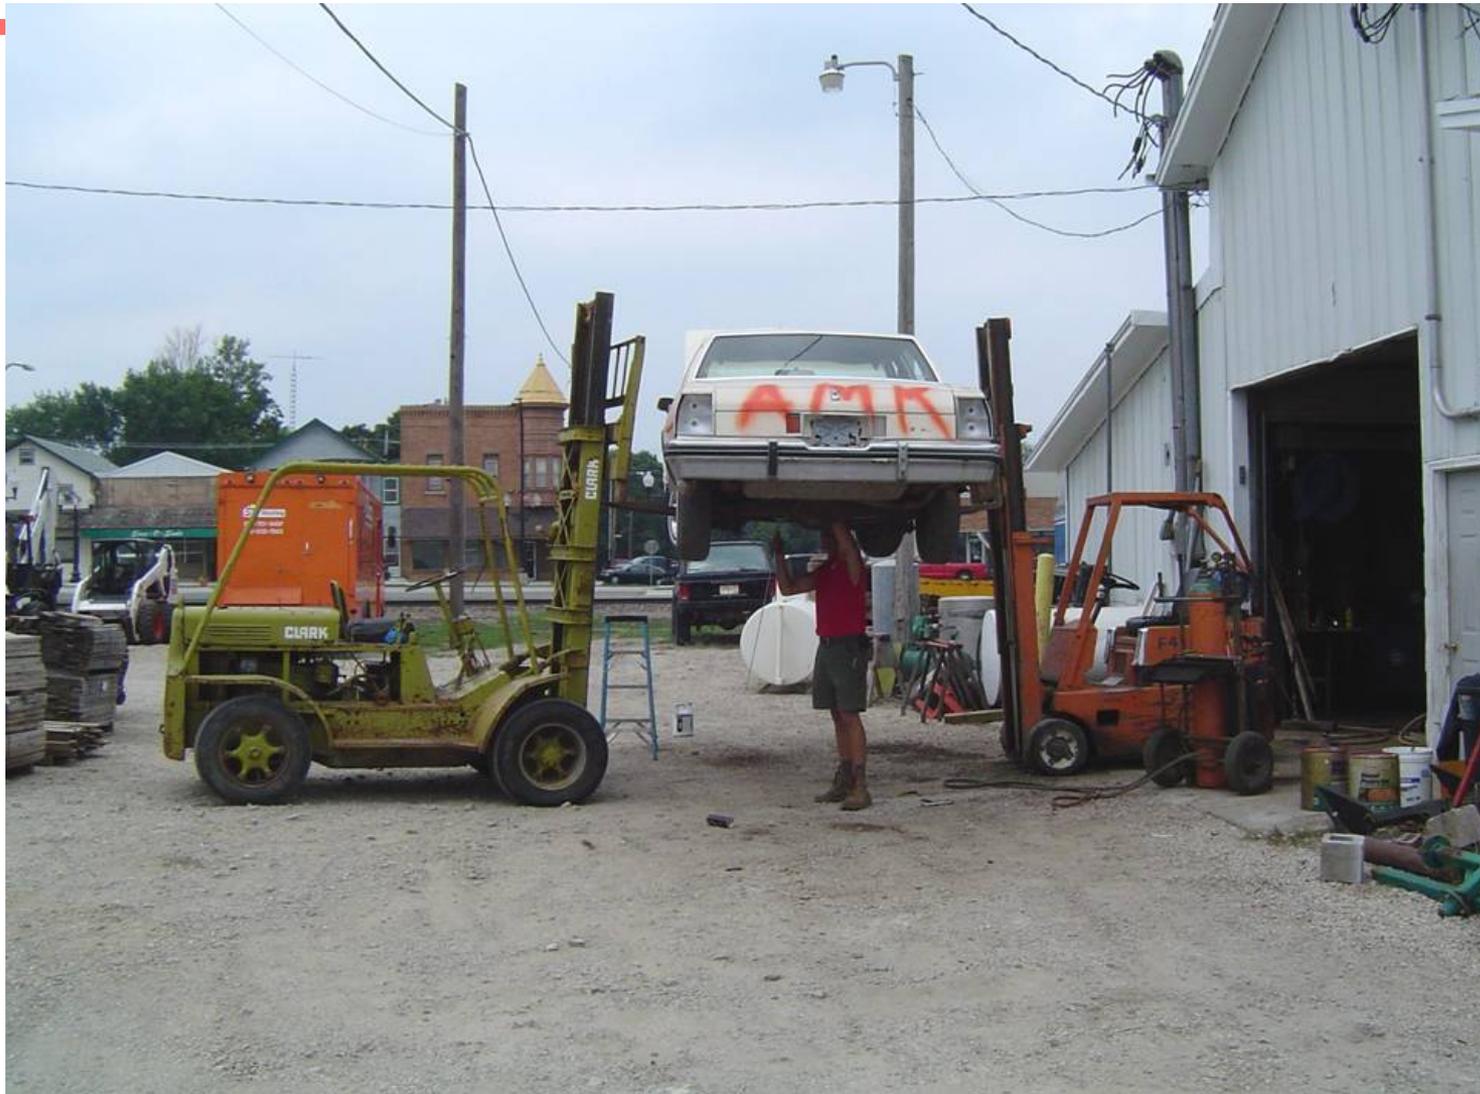
# Is that safe, maybe line of fire?

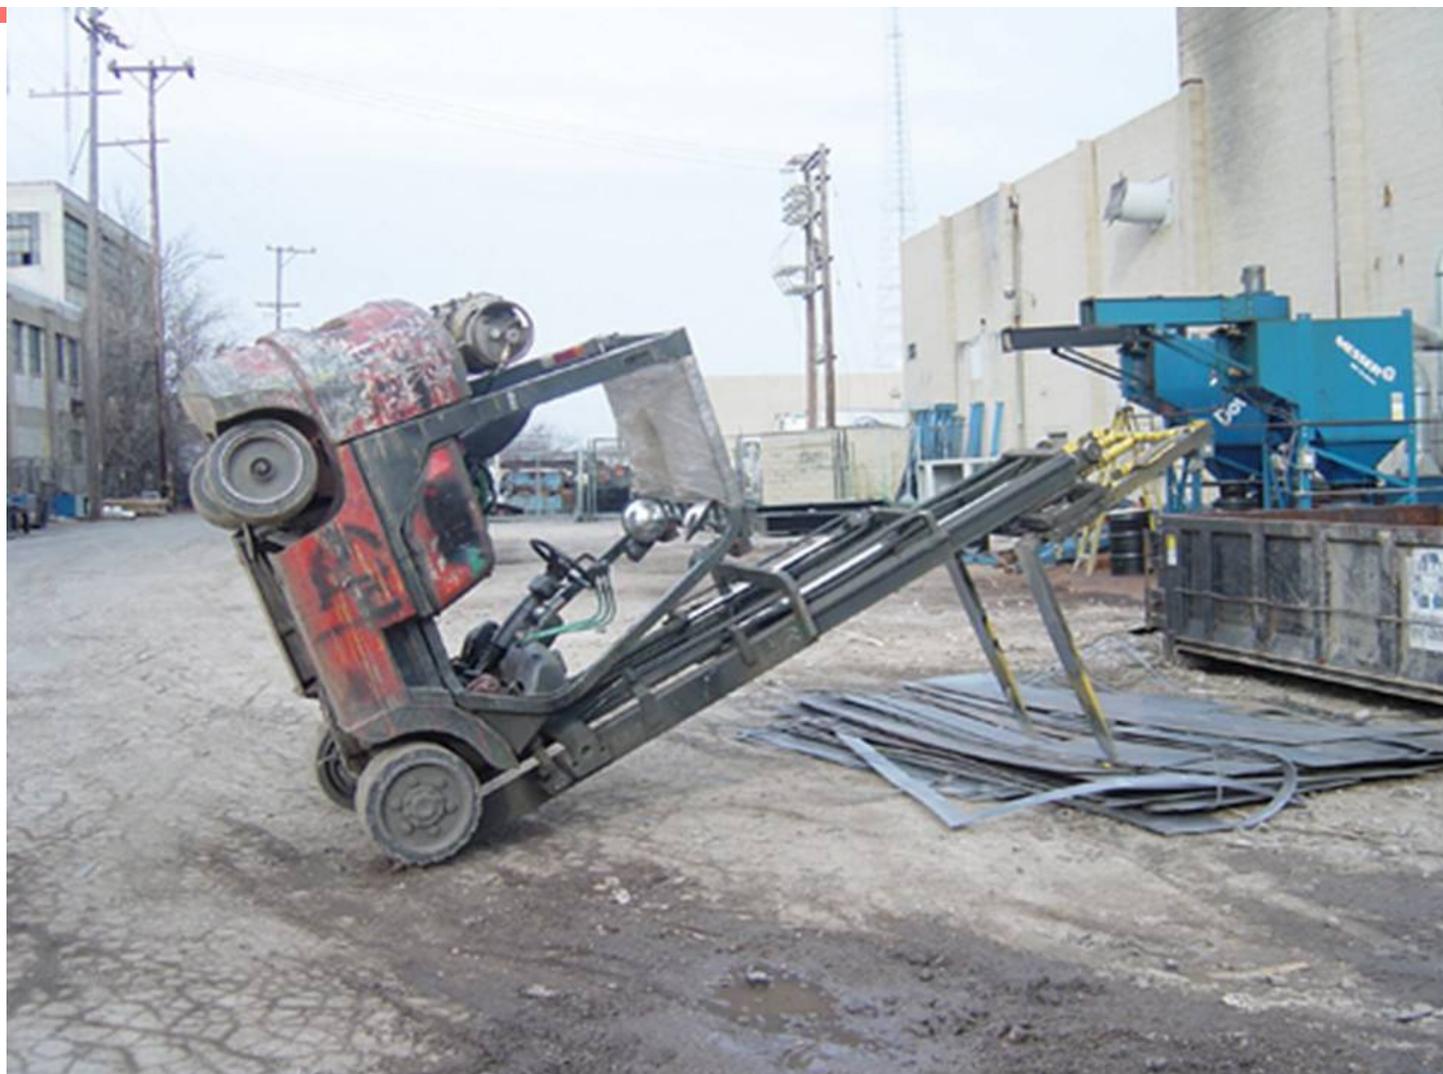
# And So the Forklift Training Continues, ISMS?

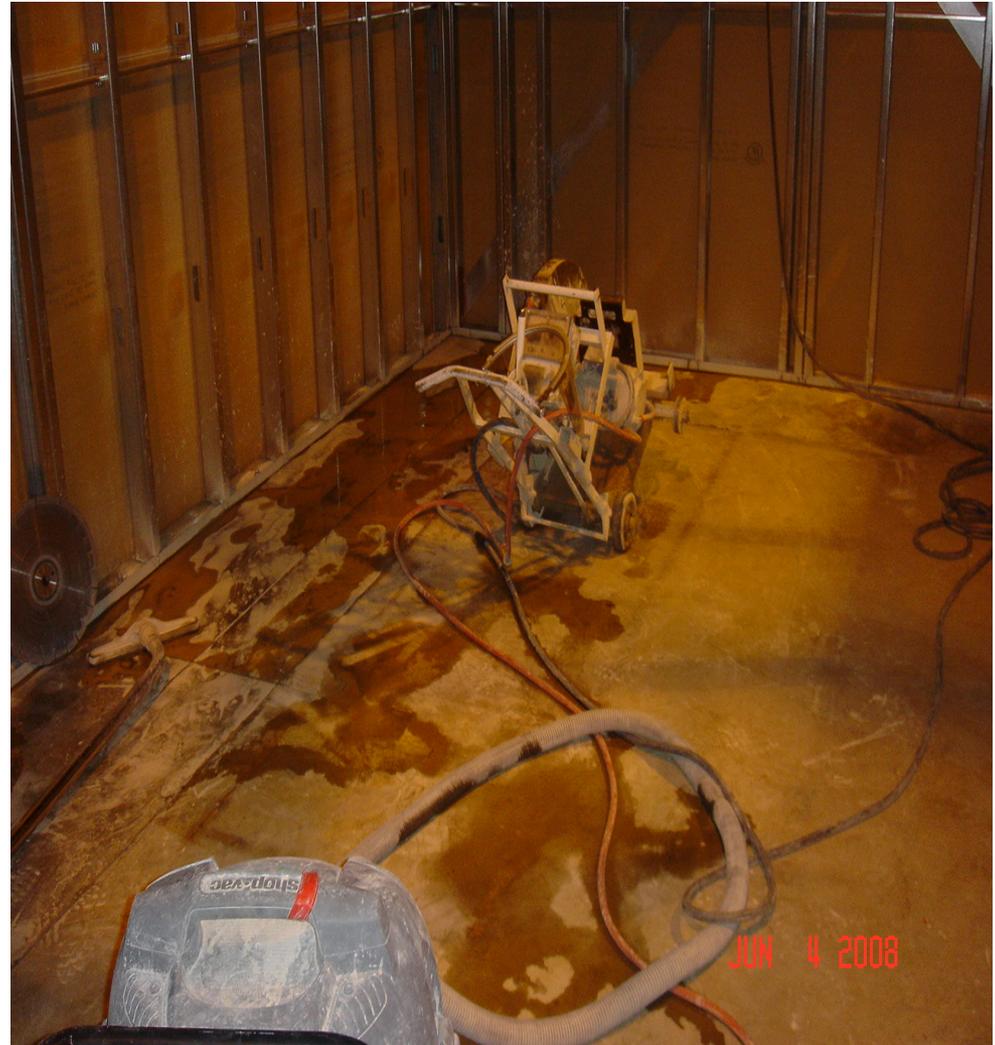
# Concrete Cutting Operations

- A concrete cutting subcontractor was saw-cutting a concrete floor, located in the Bldg. 892 basement. While cutting the concrete, a 1" conduit with four 120 volt circuits were cut in the concrete slab.

## Contacts Energized 120 Volt Conductors

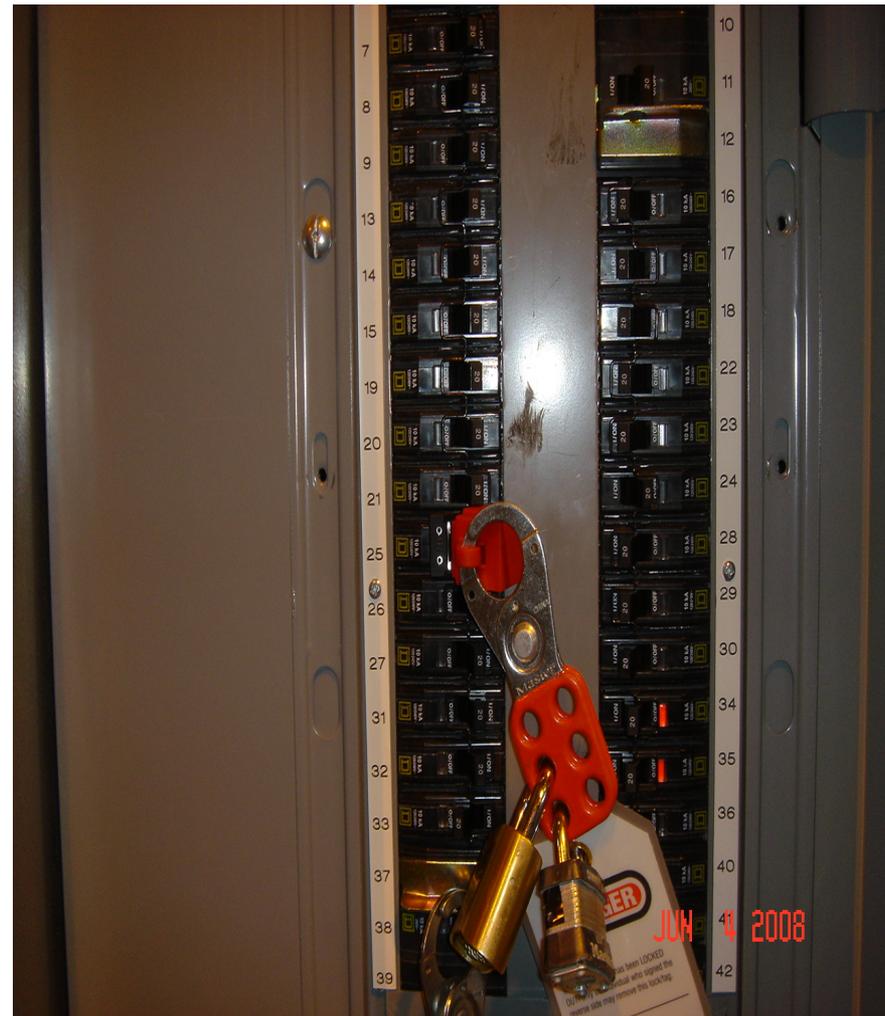
- Site investigation identified one circuit that went through the slab and that breaker was locked and tagged out.

- A penetration permit had been issued for the saw cutting activity.
- Site investigation (including drawing reviews) and spotting had been performed.
- Current technology used for spotting can identify high voltage lines but is less reliable for low voltage circuits when rebar is in floor.
- PPE is required by FMOC for all penetration activities because of the limitations of site investigation and spotting techniques.
  - The person performing the saw cutting activity was wearing required PPE (electrically rated gloves and boots) to provide protection for shock hazards.

- Interim Actions – Contractor followed SNL procedures
  - Suspension of all concrete saw cutting and core drilling (excluding sidewalks and other areas where electrical circuits are not located).
  - Conduct a review of current penetration permit process and spotting techniques to identify areas for potential improvement.
  - Lessons learned will be shared stressing the importance of wearing electrically rated gloves and boots during saw cutting and coring activities.

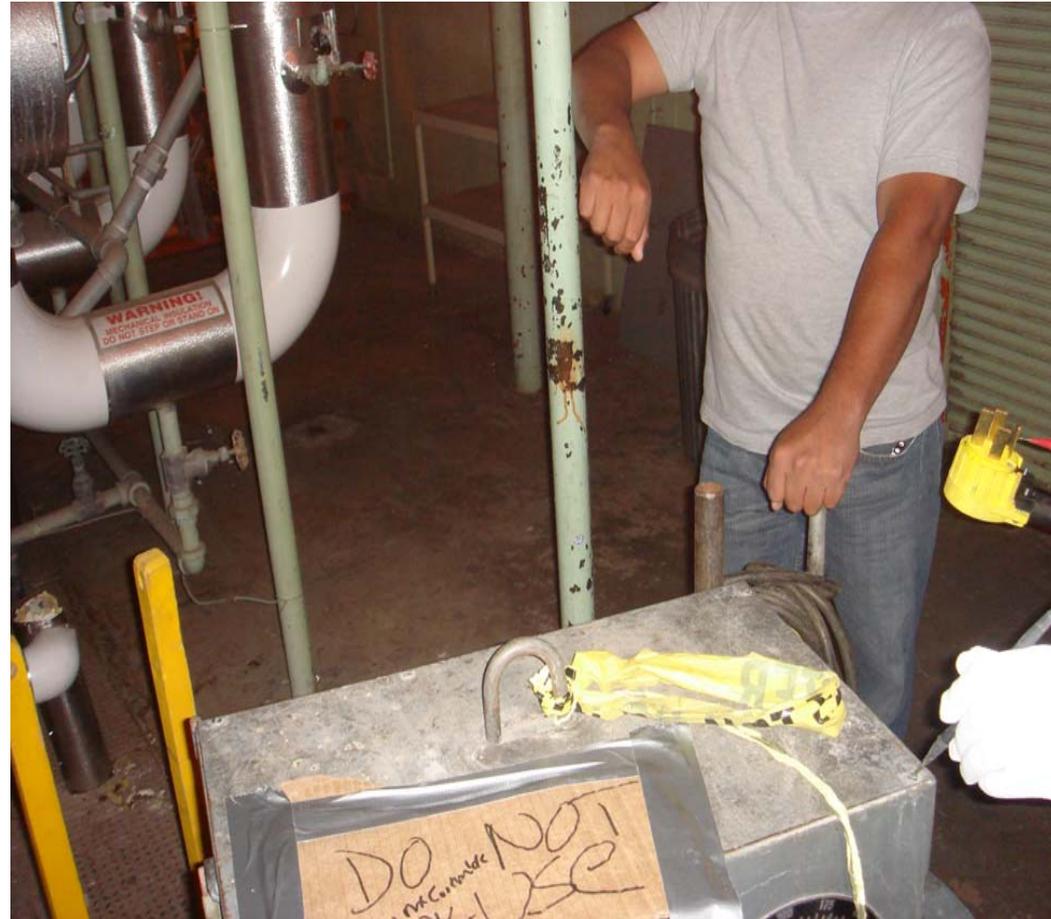
- A Mechanical Subcontract worker received a shock when the worker touched the building structure while leaning against an electric welder.

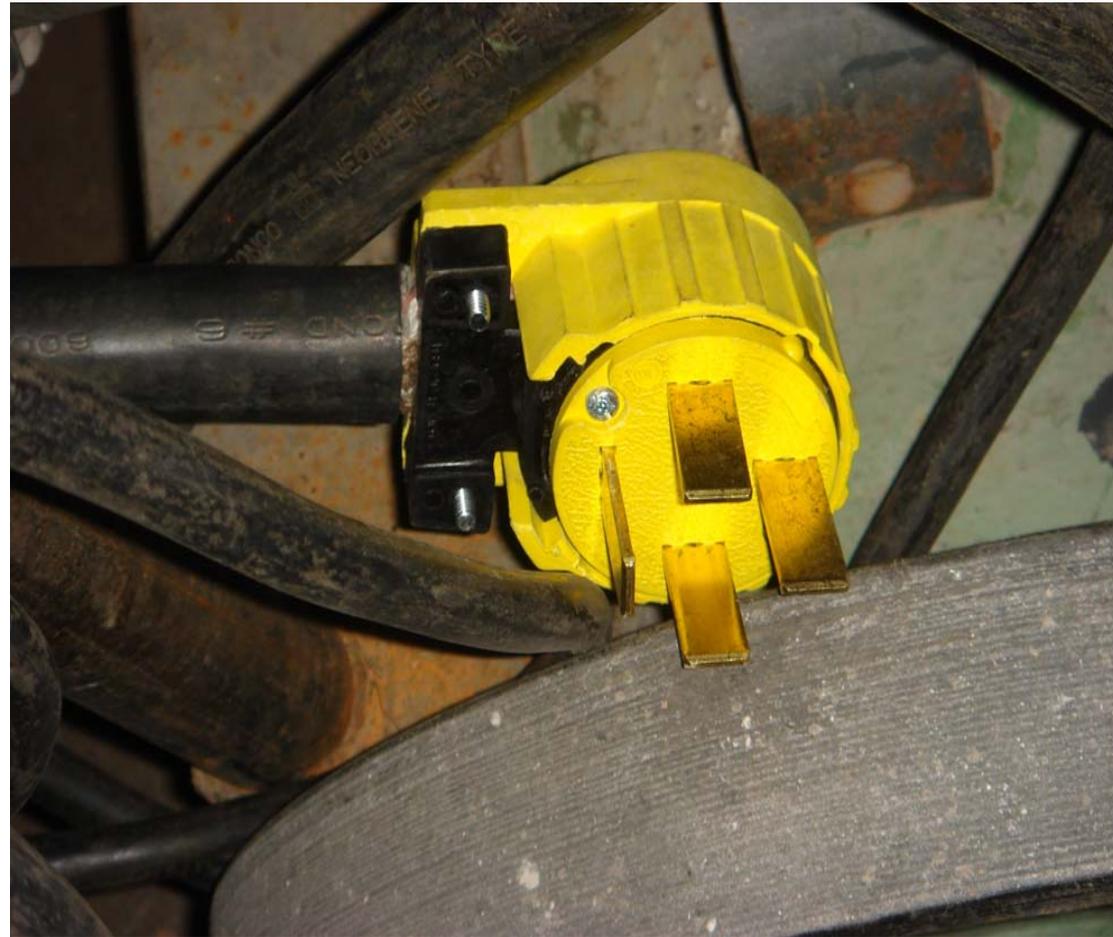
# Receptacle Supplying Power to Electric Welder Miss-wired Resulting in Electrical Shock

- The cause of the shock was an incorrectly wired 4-wire, 120/208V, 60A cord cap. The conductors feeding the ground terminal and one of the three phase terminals on the cord cap were reversed. When the welder was plugged into the wall outlet the frame of the welder became energized.

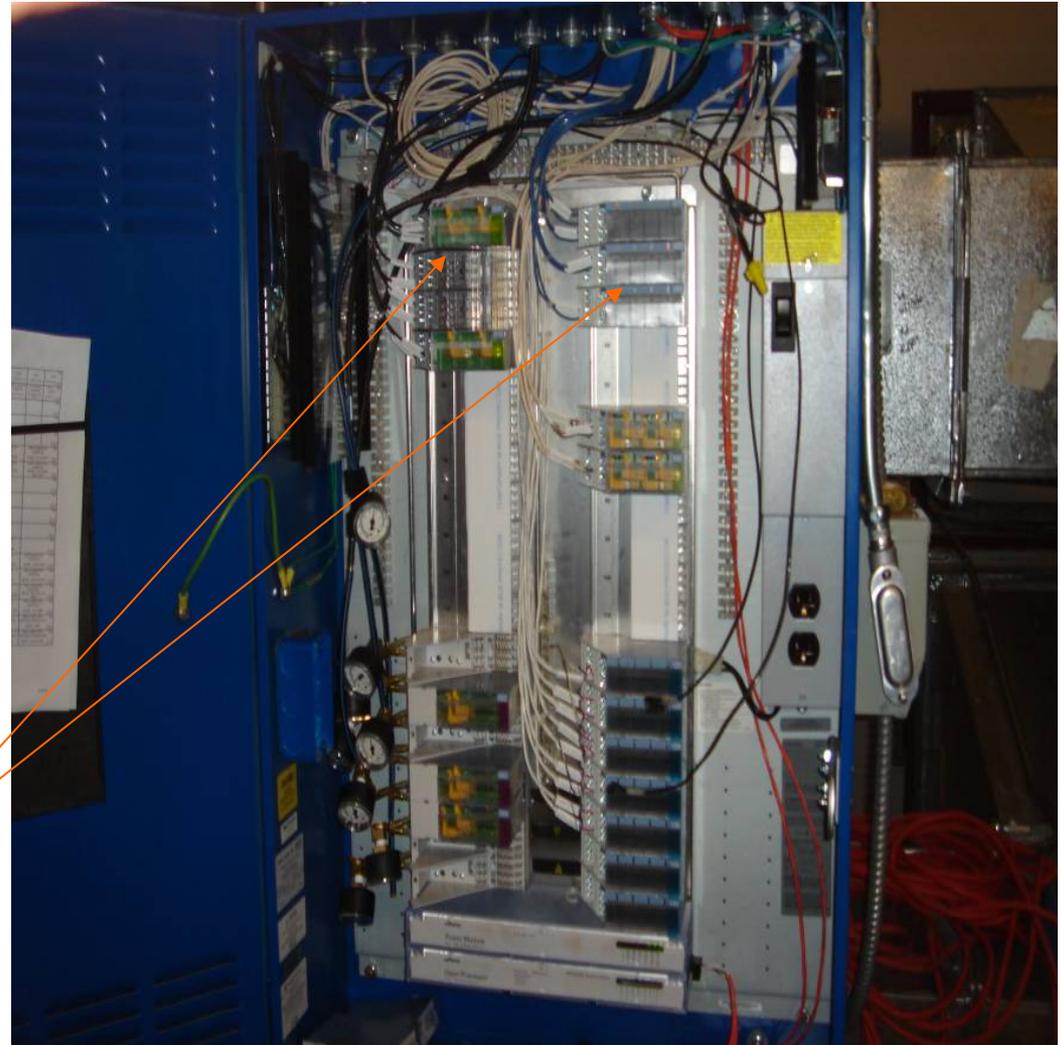
# FMOC Subcontractor Cuts Energized 120volt Conductor while Disconnecting & Removing Electrical Control

- MBC/FID Cabinet
  - Two digital outputs (DO) were “pulled” to eliminate any 120volt power supplying the components to be removed
  - The digital outputs (DO) and digital inputs (DI) points were checked for zero voltage

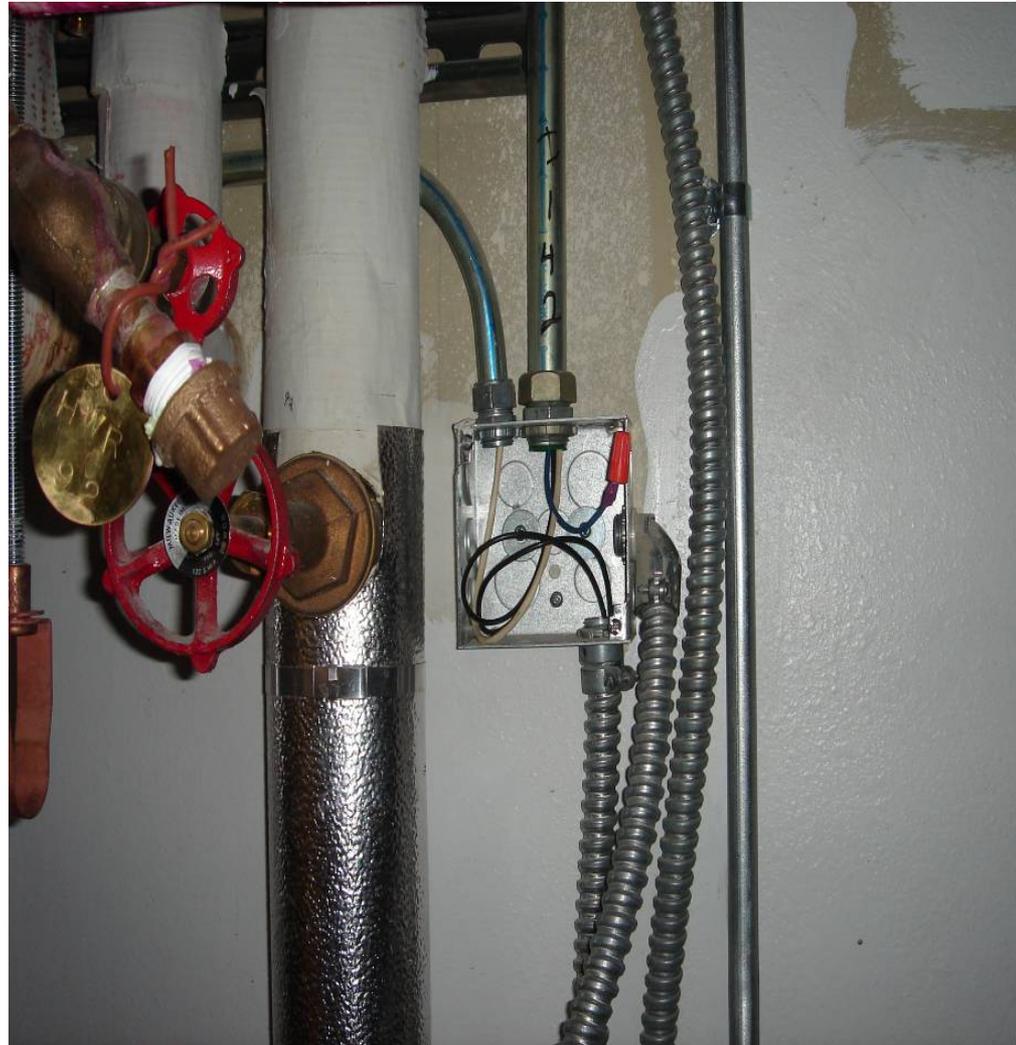
# FMOC Subcontractor Cuts Energized 120volt Conductor while Disconnecting & Removing Electrical Control

- Junction Box
    - Location the contractor cut the energized 120volt conductor
    - Tool arced to junction box when conductor was cut
- \*Note work practice is to ensure side cutters contact box when cutting conductors

- Lessons learned will be shared with construction contractors at the next Construction Safety Seminar and in the July Construction News Sense, maintenance workers at monthly safety meetings, and through the SNL Corporate lessons learned process.
  - Lessons learned will focus on the benefits of utilizing tic tracers to identify the presents of voltage in conductors passing through electrical boxes with no terminations points.

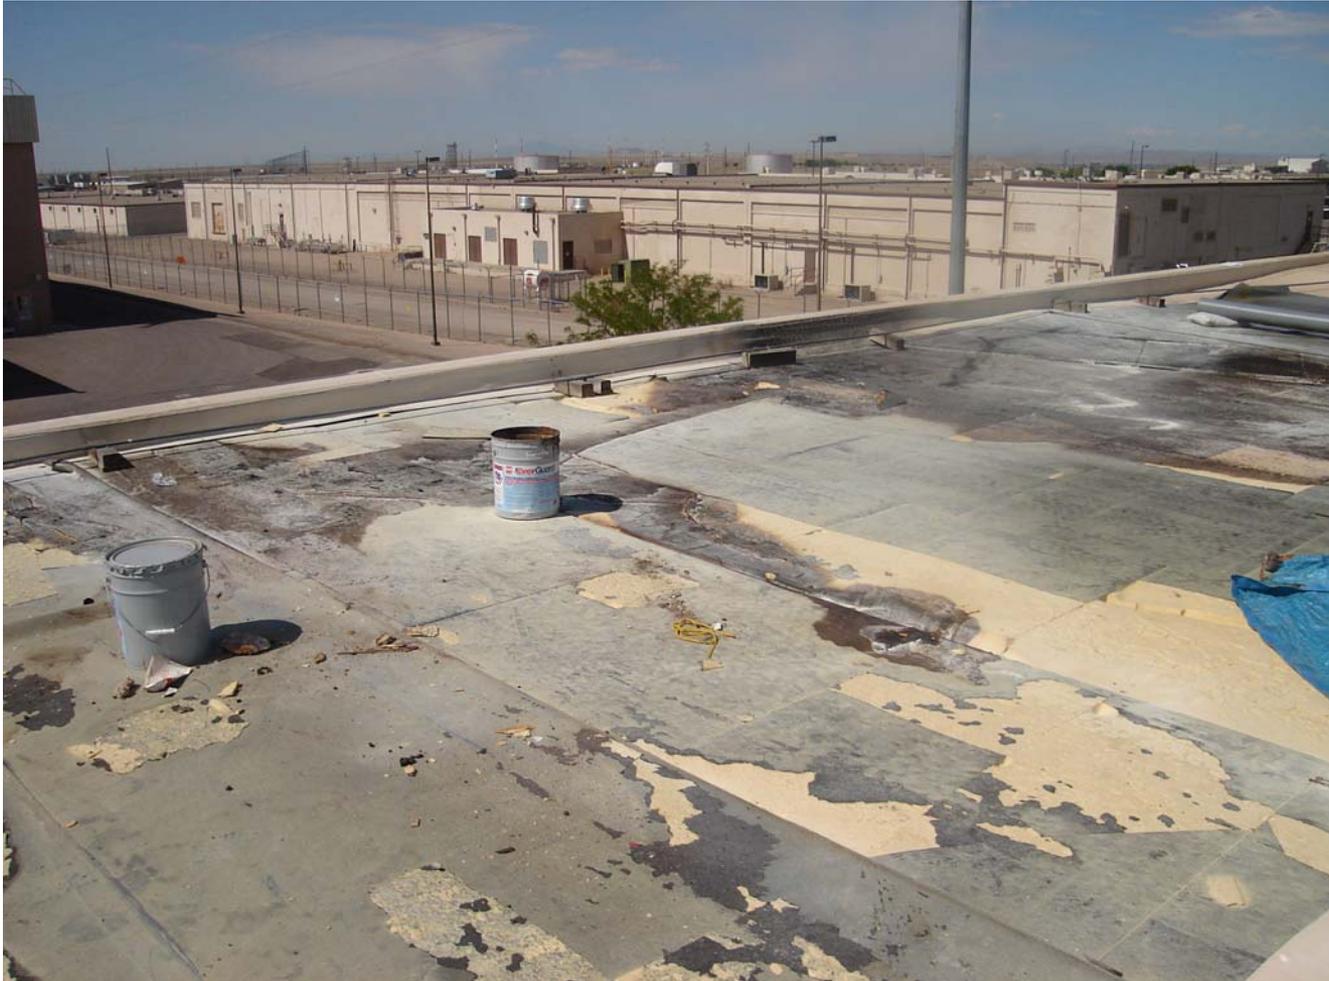
# SNL Description of Event

- A roofing services company was applying a UL Listed FM approved Bonding Adhesive to repair a single-ply-roofing system. The Bonding Adhesive contained a flammable liquid. Application of the adhesive involved using a medium nap solvent-resistant roller that was dipped into the 5 gallon metal pail, and rolled onto the roofing membranes. Workers applying the adhesive were required to walk across the roofing membrane surfaces. As a worker was using the roller in the adhesive pail a flash fire occurred within the bucket and on the roller brush.

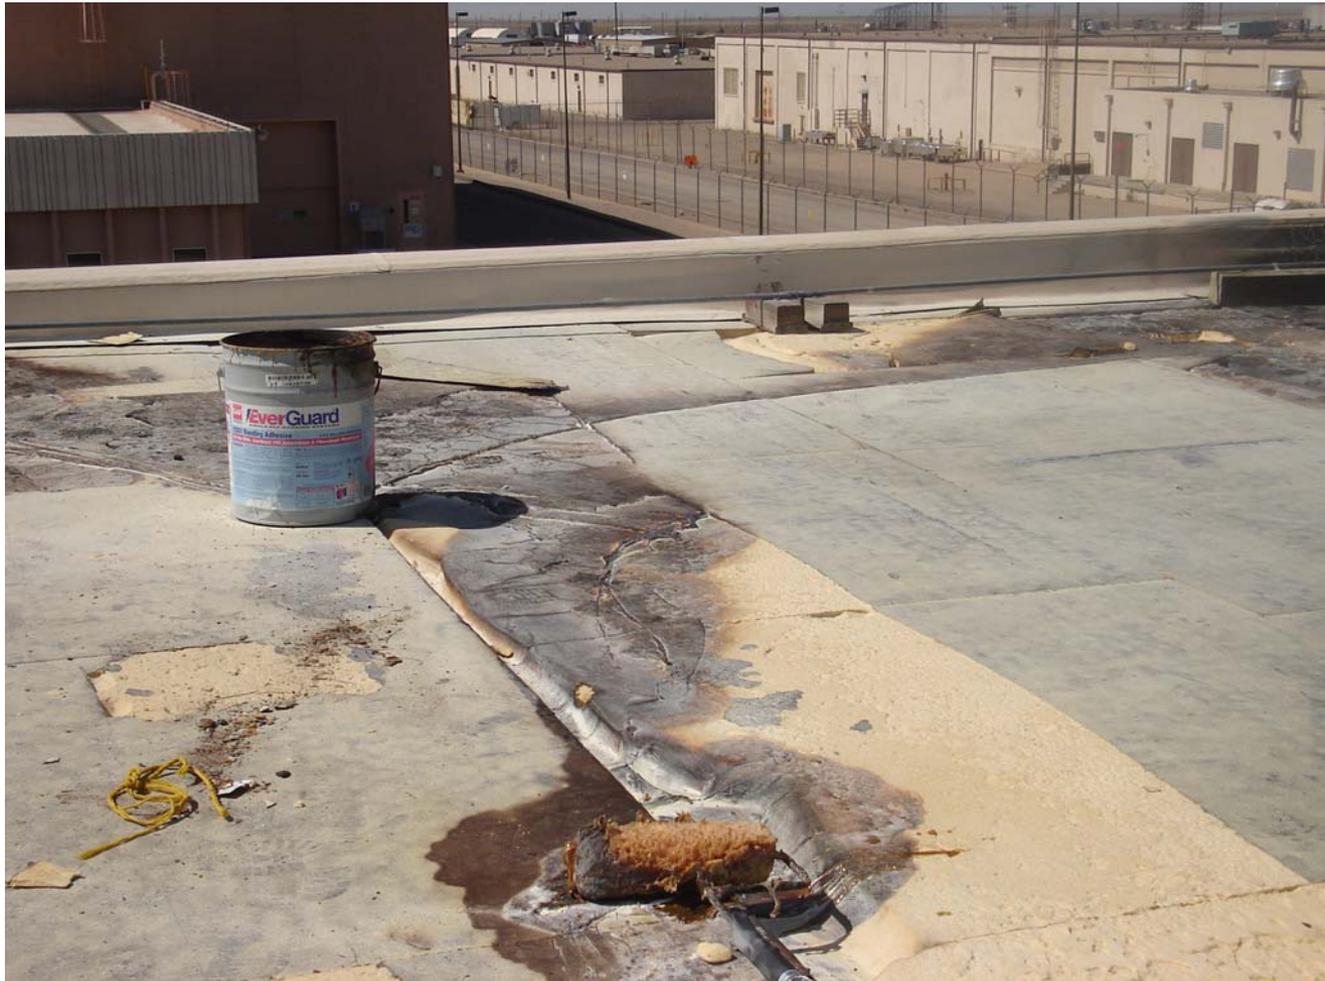
# SNL Description of Event

- The worker immediately backed away from the pail and placed the burning roller down on the roof. A flash fire occurred across the roofing membranes that had been coated with bonding adhesive. The fire was extinguished quickly by a worker using a portable dry chemical fire extinguisher. There were no injuries and minimal damage to the roof.

- Static electricity, involving separation charging (also called triboelectric charging or frictional charging) was considered to be the most probable source of fire ignition resulting from static accumulation by personnel working in dry weather, very low humidity and walking across exposed roofing membranes (e.g., un-faced polyiso insulation) without properly bonding and grounding the adhesive roller to the outside the pail to dissipate and equalize the static potential.

- Roofing Contractor will develop an Activity Hazard Analysis and provide training to workers who use this type of adhesive product.
- When introducing a new potentially hazardous product into the workplace, contractors should perform a hazard analysis to determine hazards and suitable controls.
