Appendix A: PCCV Model Design Drawings

List of PCCV Design Drawings

NAME	SHEET	NUPEC PCCV STRUCTURAL BEHAVIOR TEST MODEL	SCALE
NUPEC SYSTEMS SAFETY DEPT.		MODEL-GENERAL ARRANGEMENT	1/100 1/150
S N L	COPY 1		REVISION NO.
NUCLEAR SYSTEMS ENGINEERING DEPT.		MITSUBISHI HEAVY INDUSTRIES, L.T.D.	R2
STEEL STRUCTURE DESIGNING SECT.	COPY 1	OBAYASHI CORPORATION	
EQUIP DESIGN SECT.	COPY 1		
TAKASAGO R&D CENTER	COPY 1		
T A I S E I	COPY 1		
OBAYASHI	ORIG.

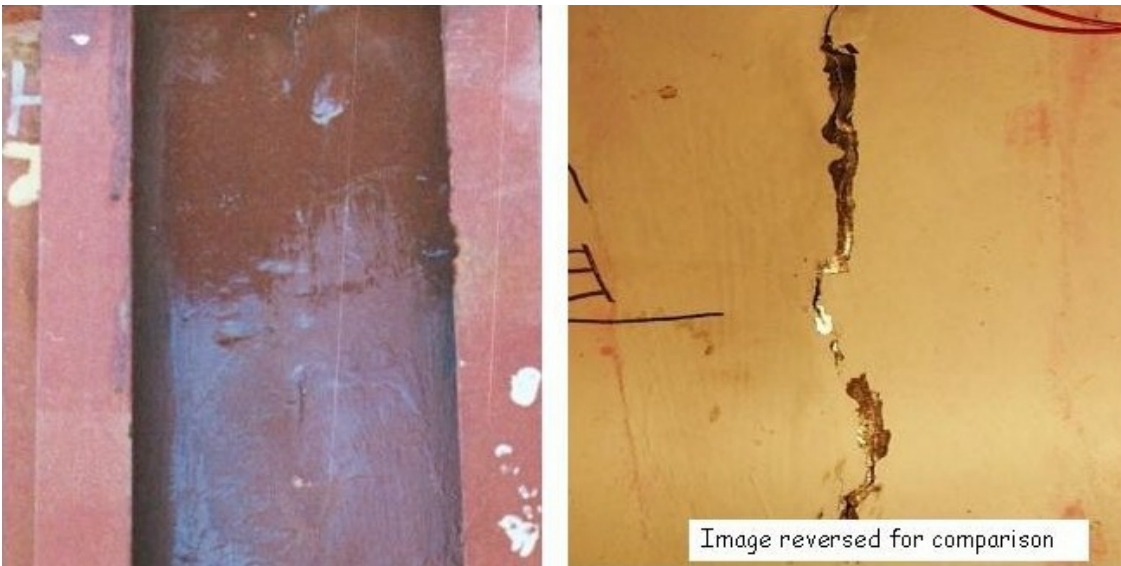
Figure 4. Photographs showing region of tear #4-1 from outside of liner (left) (prior to concrete placement) and inside of liner (right) (prior to removal of paint). Separate tears began of opposite sides of the weld, eventually growing together through the fusion zone.

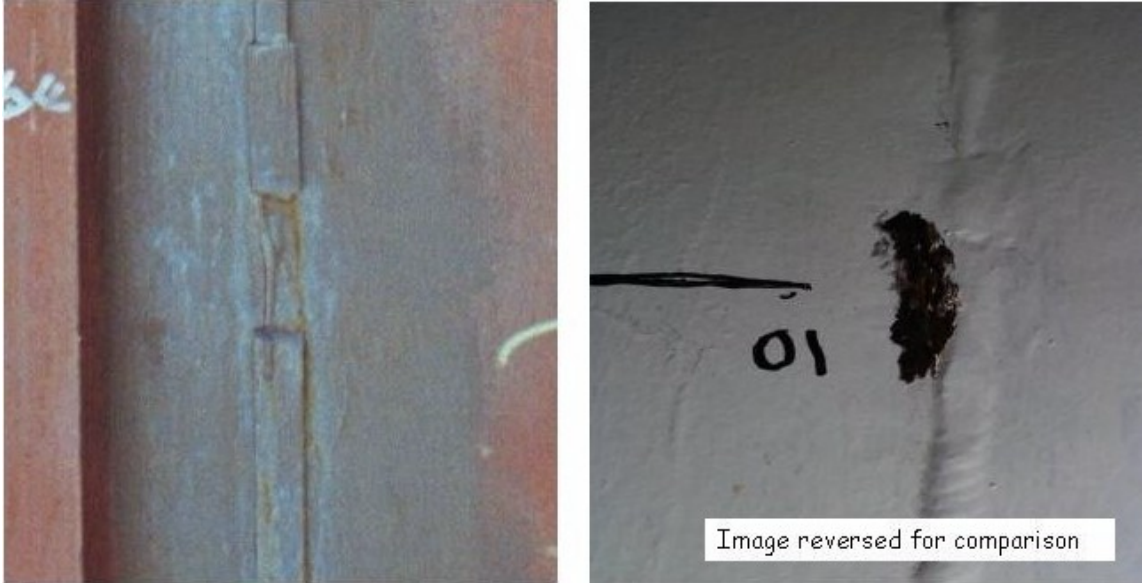
Figure 9. Photographs showing region of tear #10 from outside of liner (left) (prior to concrete placement) and inside of liner (right) (prior to removal of paint). Note missing segment of back-up bar in vicinity of repair weld and tear.

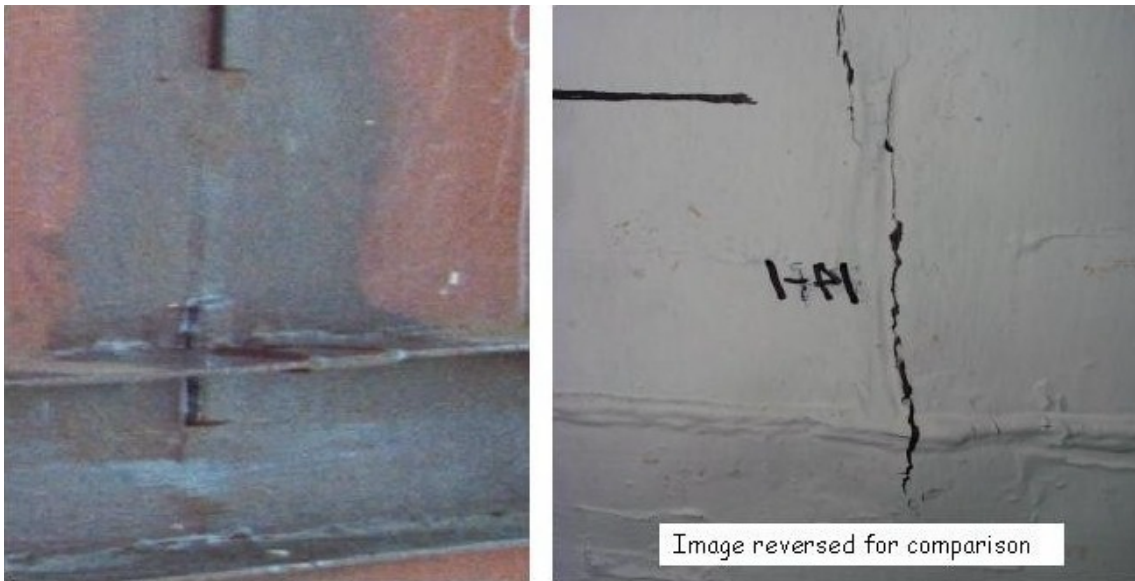
Figure 10. Photographs showing region of tear #14-1 from outside of liner (left) (prior to concrete placement) and inside of liner (right) (prior to removal of paint). Note missing segments of back-up bar in vicinity of repair weld and tear.

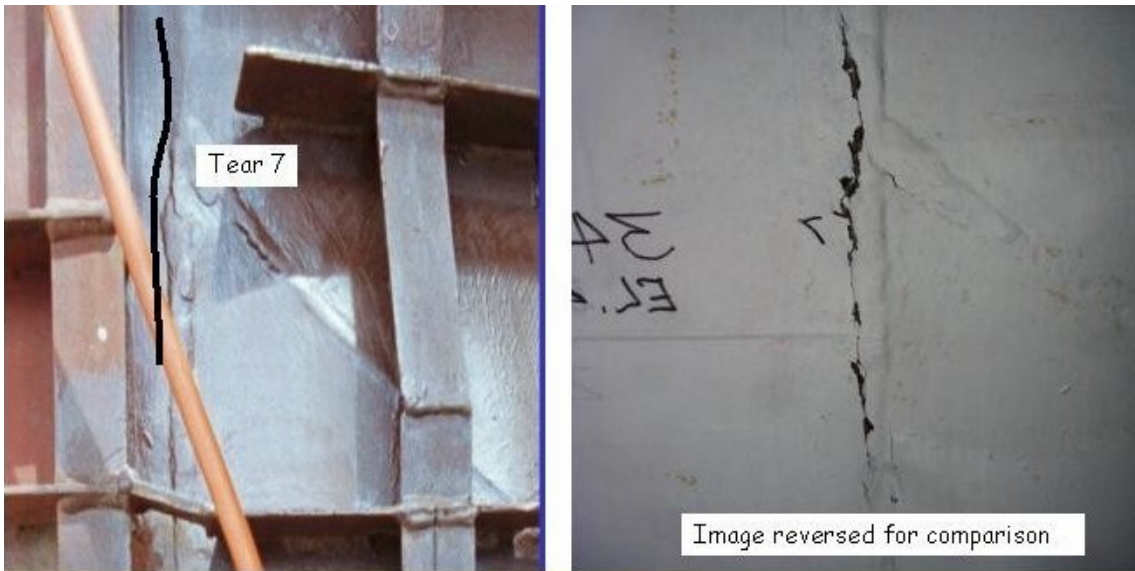
Figure 15. Photographs showing region of tear #7 from outside of liner (left) (prior to concrete placement) and inside of liner (right) (prior to removal of paint).

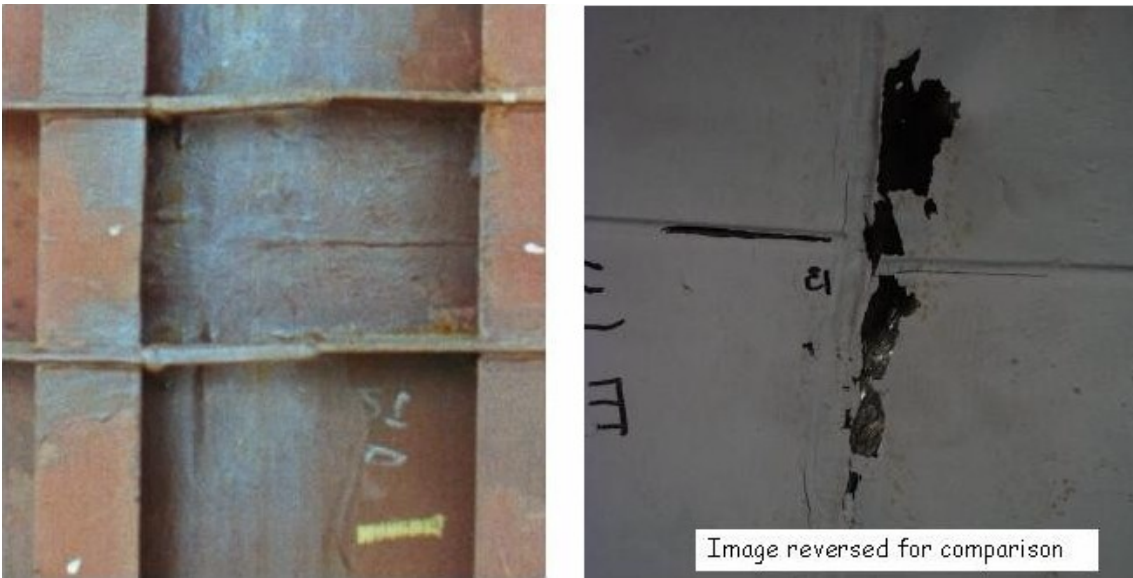
Figure 18. Photographs showing region of tear #13 from outside of liner (left) (prior to concrete placement) and inside of liner (right) (prior to removal of paint).

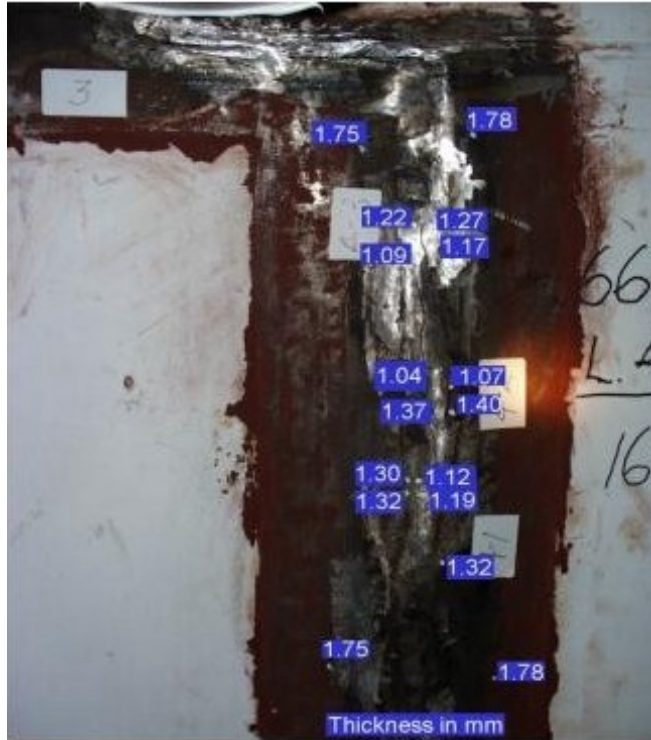
Figure 21. Liner thicknesses (in millimeters) measured ultrasonically in the vicinity of tear #4 (4-1, 4-2, and 4-3).

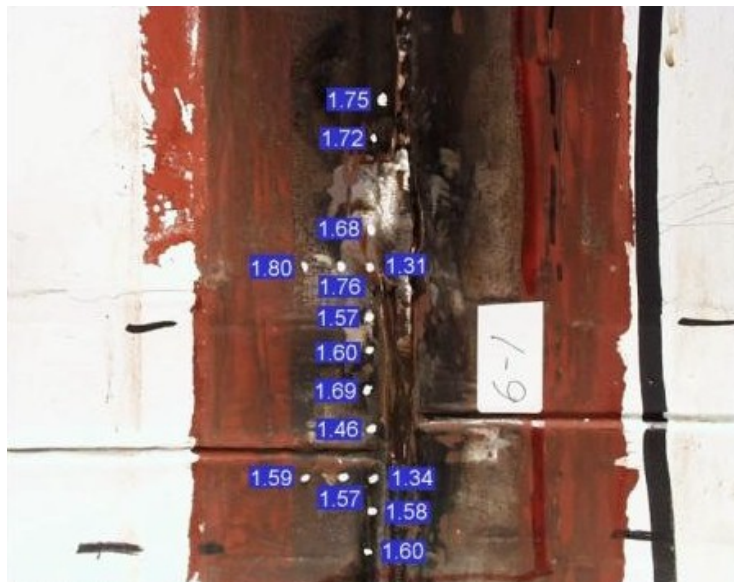
Figure 22. Liner thicknesses (in millimeters) measured ultrasonically in the vicinity of tear #6-1.

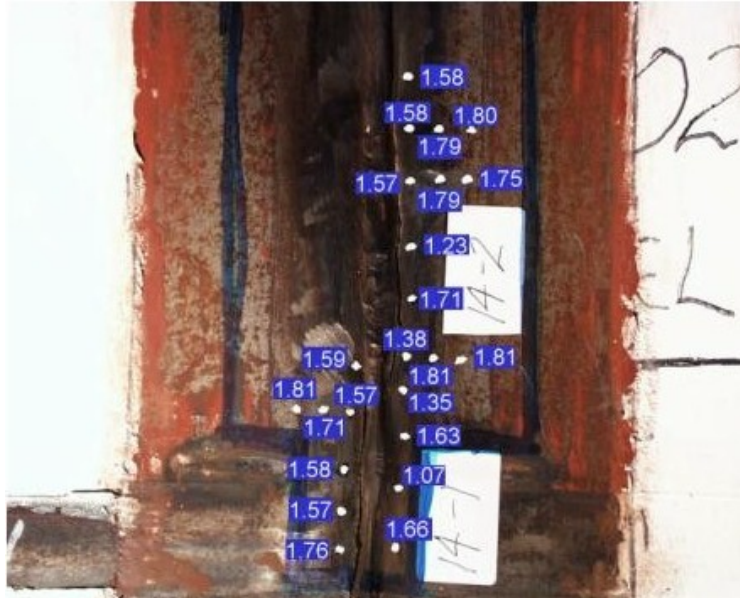
Figure 29. Liner thicknesses (in millimeters) measured ultrasonically in the vicinity of tear #14 (14-1 and 14-2).

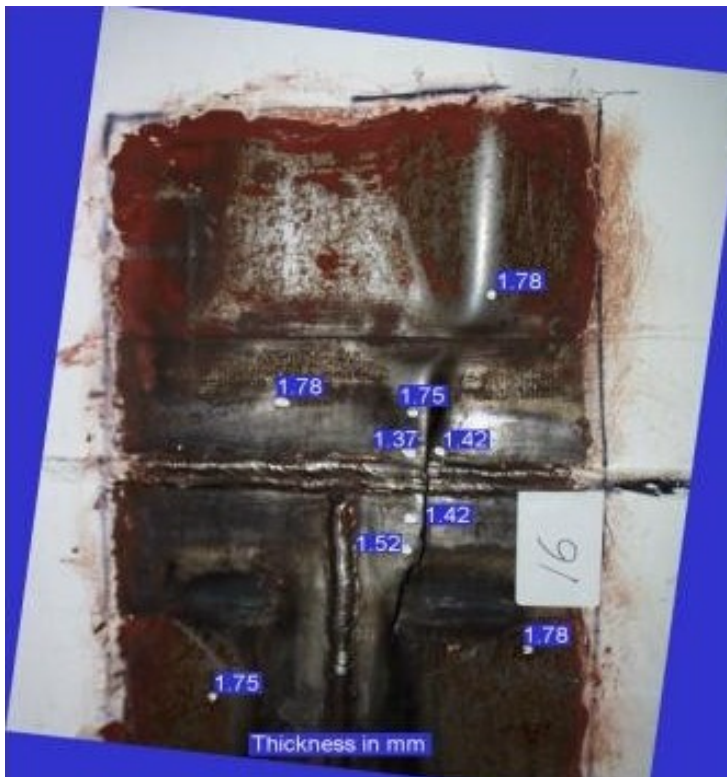
Figure 30. Liner thicknesses (in millimeters) measured ultrasonically in the vicinity of tear #16. Note distance of tear from vertical weld and extensive buckling above tear.

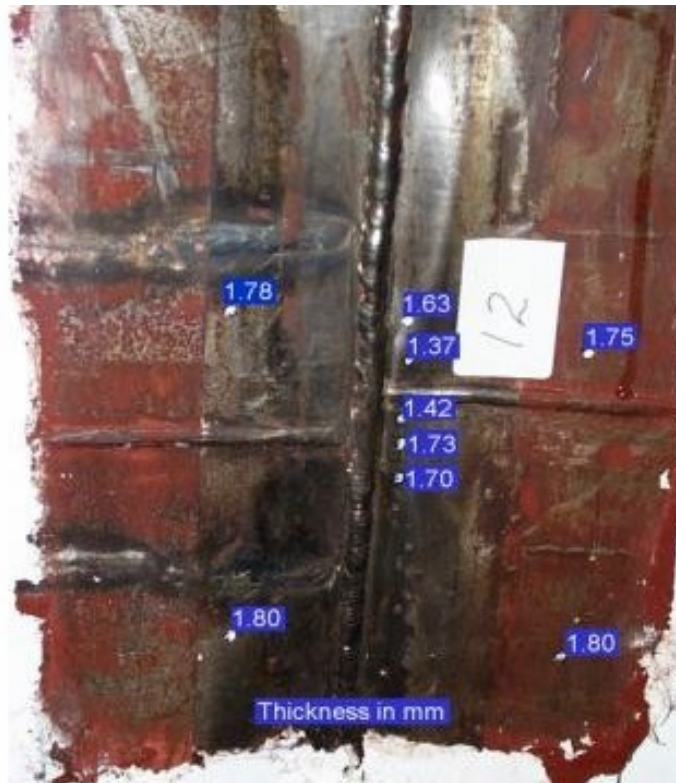
Figure 34. Liner thicknesses (in millimeters) measured ultrasonically in the vicinity of tear #12.

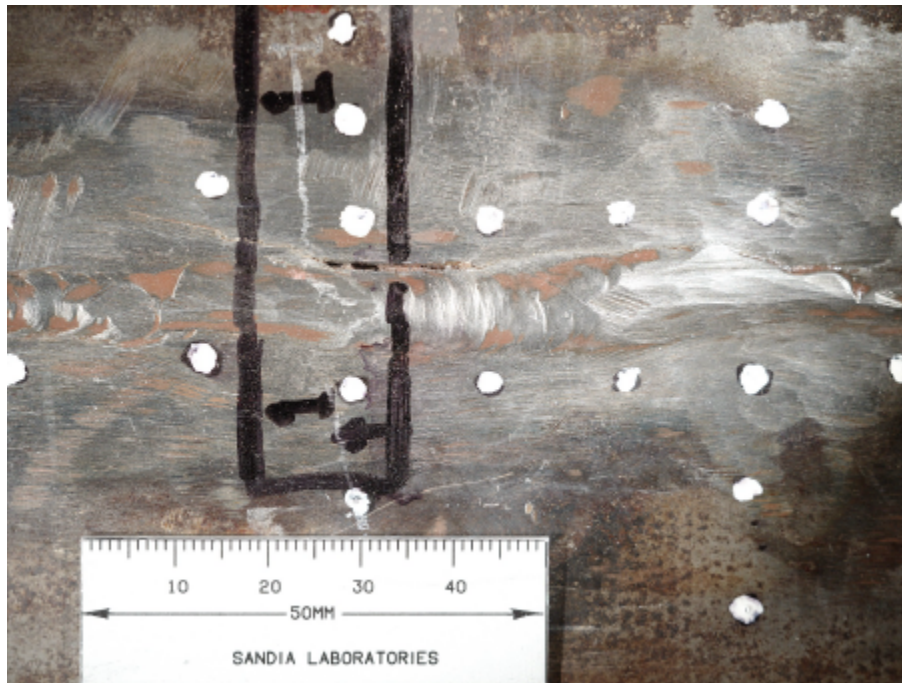
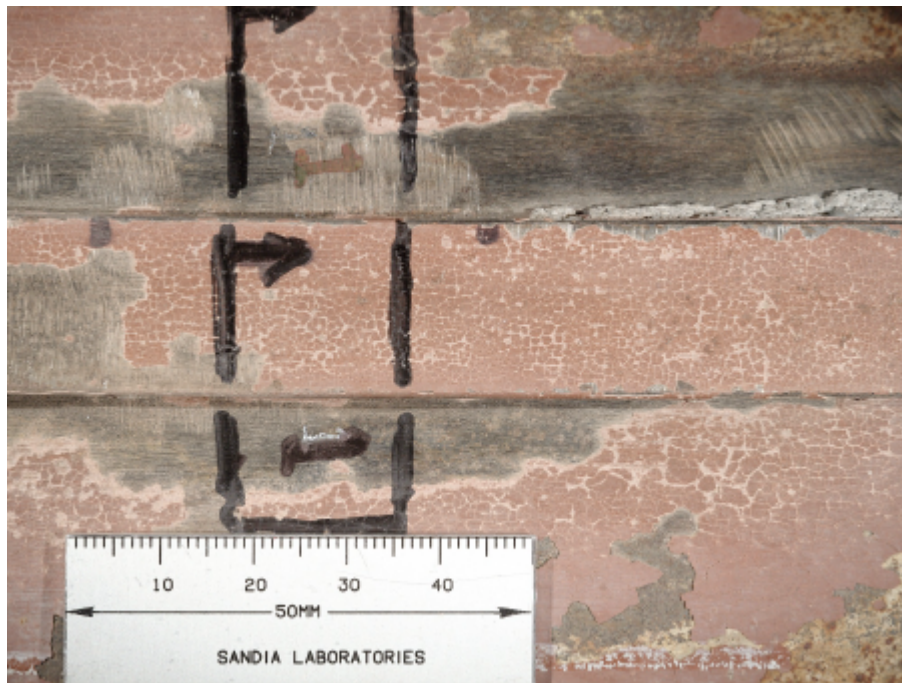
Figure 49. Details of inside (top) and outside (bottom) liner features in region of tear #1 metallographic cross-section (arrows begin at plane of section and indicate view direction).

As a check, an additional cross-section was polished ~2 cm down the tear from the initiation site, at a location removed from the weld defect (the opposite edge of the cross-section sample, shown in Figure 49). This cross-section is shown in Figure 67. The tear appeared quite different in this location: a predominantly 45 degree shear failure accompanied by substantial local plastic deformation. This clearly represents a region where the tear had propagated into sound metal after having been initiated at the nearby weld defect. The amount of grinding estimated from the deformation-reduced thickness at the tear in this location was ~20%, in excellent agreement with the 22% measured in the undeformed area adjacent to the weld defect.

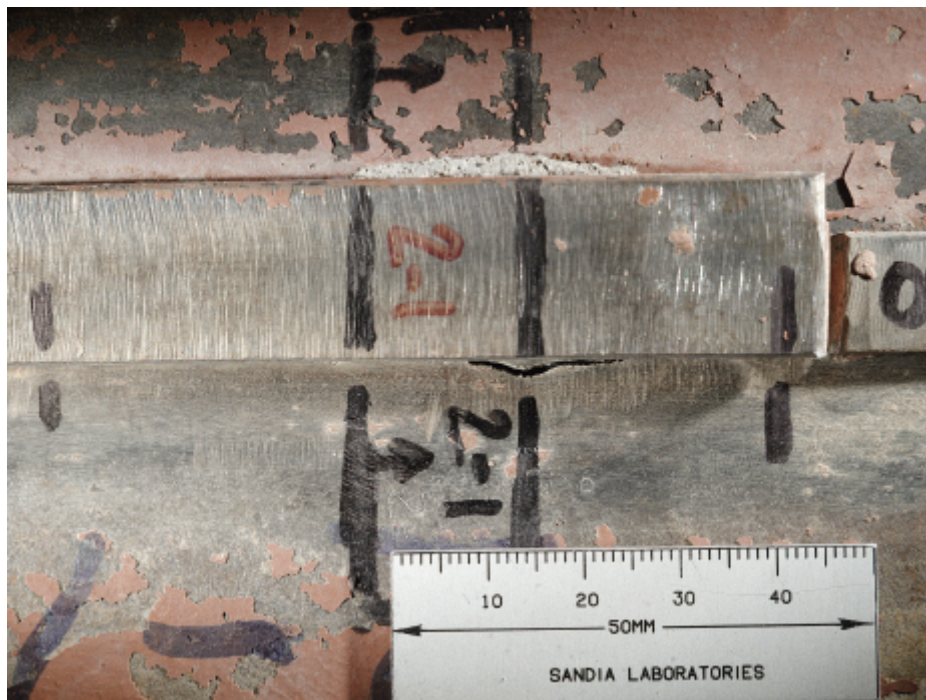
Figure 50. Details of inside (top) and outside (bottom) liner features in region of tear #2-1 metallographic cross-section (arrows begin at plane of section and indicate view direction).

Another distinguishing characteristic of this weld was the large number of short segments of back-up bar resulting from repetitive repair of this joint (Figures 3, 50 and 51). In addition to being short, three different cross-sections of back-up bar were used. These included sections of 3 mm x 13 mm, 3 mm x 19 mm, and 6 mm x 25 mm. Metallographic and hardness measurements on various portions of back-up bar showed ferrite and pearlite microstructures ranging from R_B 62 to R_B 70. It was not clear whether these back-up bar variations contributed significantly to tearing in this area or others.

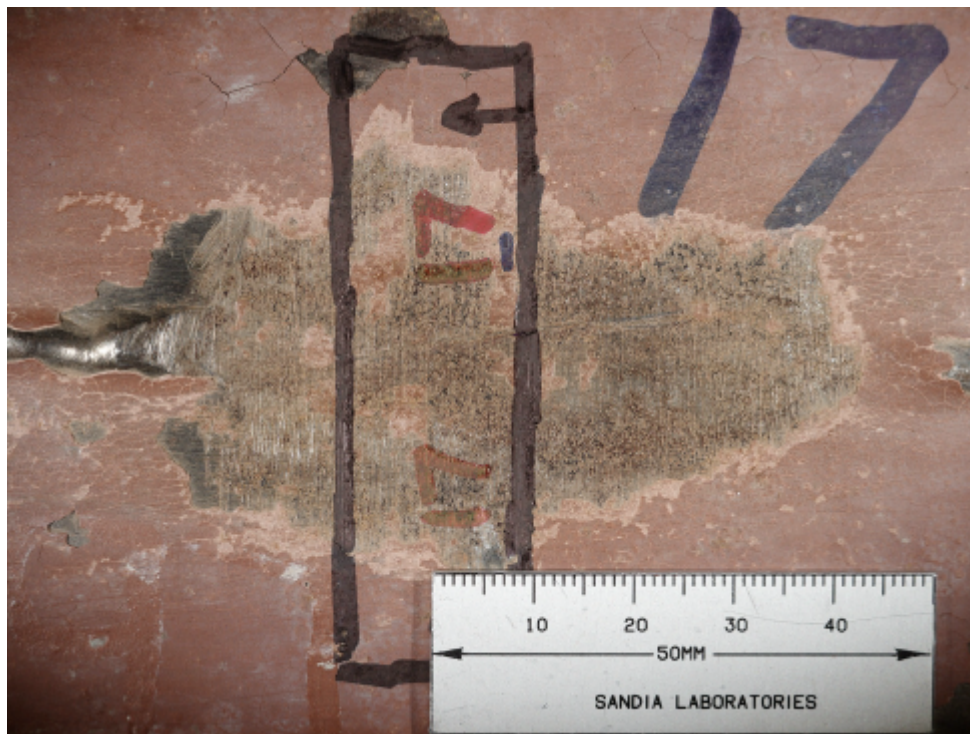
Figure 59. Details of inside (top) and outside (bottom) liner features in region of tear #17 metallographic cross-section (arrows begin at plane of section and indicate view direction).

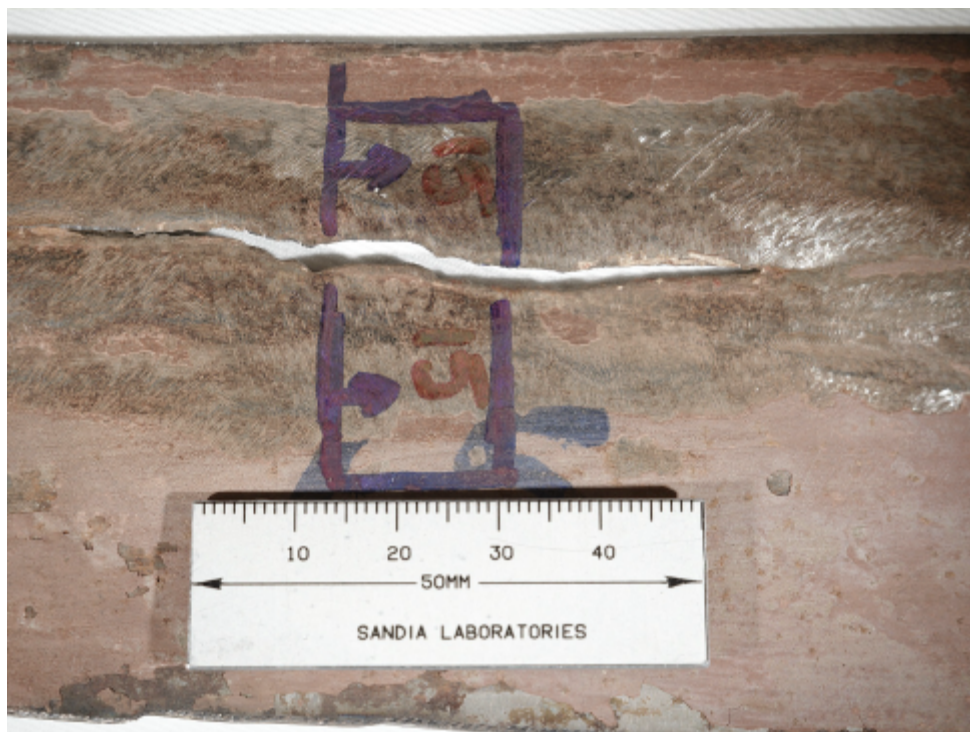
Figure 61. Details of inside (top) and outside (bottom) liner features in region of tear #15 metallographic cross-section (arrows begin at plane of section and indicate view direction).

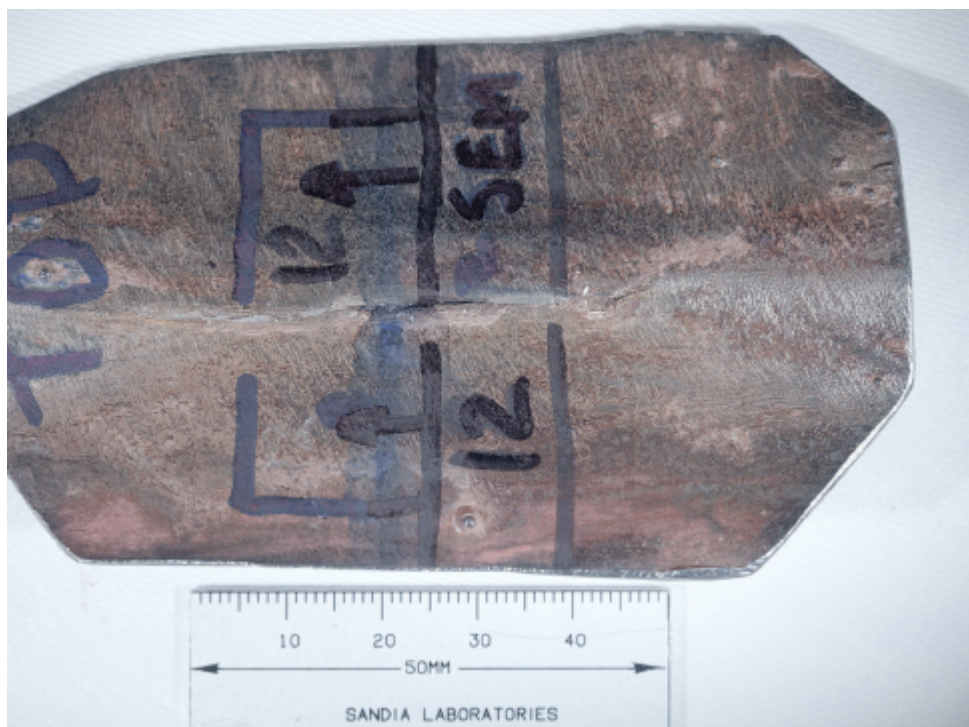
Figure 62. Details of inside (top) and outside (bottom) liner features in region of tear #12 metallographic cross-section (arrows begin at plane of section and indicate view direction). Location of SEM fractographic sample is also shown.
