# **SANDIA REPORT**

SAND2014-20600

## **Empirically Derived Strength of Residential Roof Structures for Solar Installations**

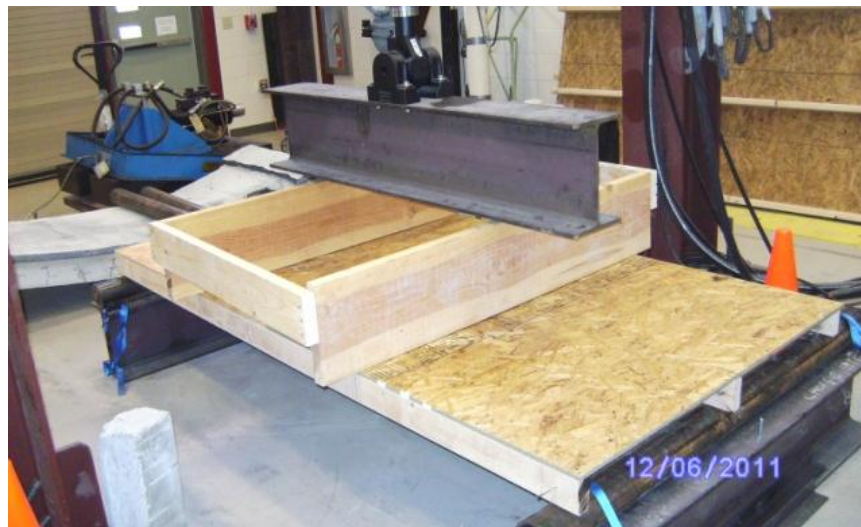
As a scoping exercise, the team loaded three wood joist and structural sheathing assemblies similar to those commonly used in residential roof systems to failure in a four-point bending test. All of the assemblies consisted of three simply supported 2"×4"×8' hem-fir joists visually graded as studs by the Western Wood Products Association, spaced at 24" on-center. The oriented strand board's (OSB's) strong axis was oriented perpendicular to the longitudinal axis of the joists. Two of the three-joist assemblies had 7/16"×4'×4' OSB panels attached to the top of the joists, as shown in Figure. 2, leaving a 1/8" gap at midspan. One assembly was constructed with nailed joints and the other with glued-and-nailed joints (8 penny [8d] nails at 11.5" spacing, PL 400 Floor and Deck semi-structural adhesive) to connect the OSB panels to the joists. As a control, the third assembly consisted of three joists without sheathing. The support and loading geometry and the resulting cracking patterns for the three tests are shown in Figure. 3. The load was applied using displacement control at a rate of 0.10 in/min.

**Figure 2. Photograph of test setup.**

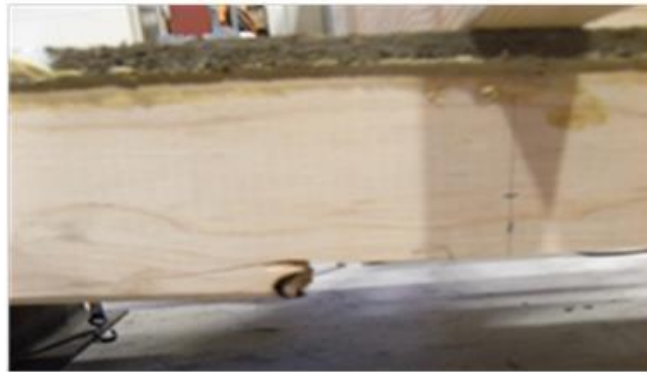
**Figure 3. Sketch of cracks in tested joists, and photo of typical crack initiation at knot on tensile face of joist.**

In all of the tested assemblies, only one of the three joists failed, perhaps because they were loaded under displacement control. The first joist to fail was always on one side of the assembly. Figure 3 also shows the locations of the cracks that initiated failure in each failed joist (in each case, initiated at the location of a knot on the tensile side of the joist) and their approximate trajectories.

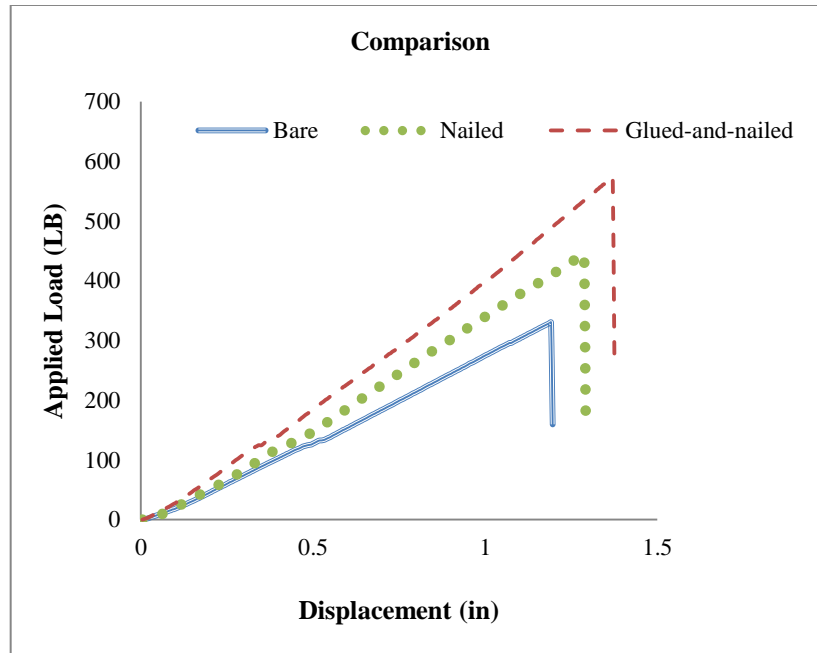
As shown in Figure 4, a load-capacity increase of 73.4% for the glued-and-nailed assembly and a 34.5% increase for the nailed-only assembly, relative to the bare-joist assembly, indicates increased strength for composite assemblies. Nonetheless, this strength increase could be due to the high variability in the bending strengths of the joists themselves, and thus, a larger set of experiments was needed to determine whether this behavior was repeatable.

Figure 4. Comparison between loading-displacement relations of preliminary tests.

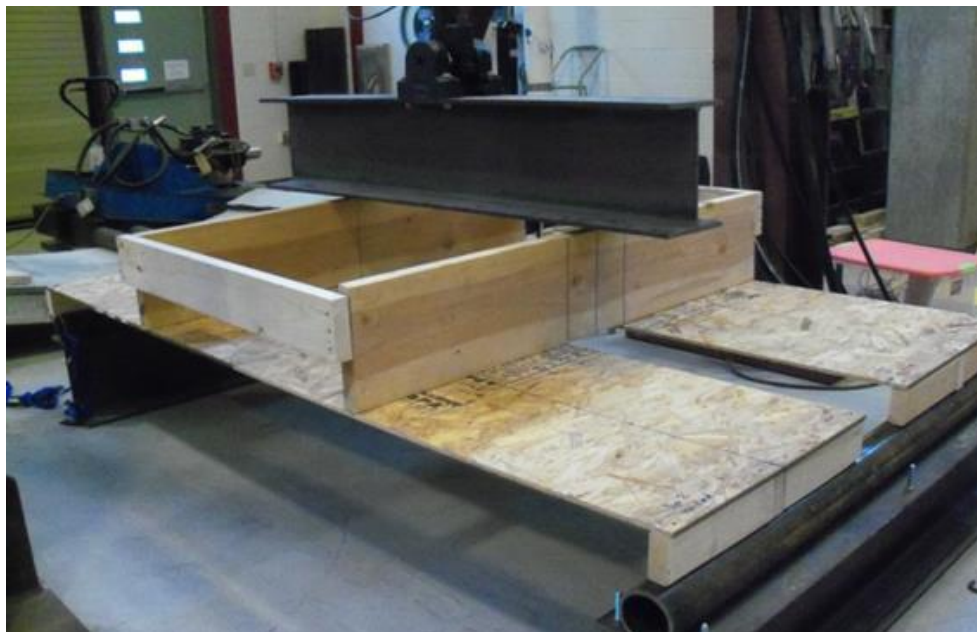
Next, the research team performed a set of eight flexural tests to provide more data to better understand the results we obtained in the preliminary tests. These specimens were slightly modified to avoid load-sharing effects and to isolate the effects of composite action between the joist and the OSB. Each specimen consisted of one 2"×4"×8' joist (also visually graded as stud) with two 2'×4', 7/16" OSB panels attached on the top, to form a T- beam (with a 24"-wide flange and the same 1/8" gap at midspan), as shown in Figure 5.

Two bare joists and six composite joists (three with nails and three with nailed-and-glued connections, all on an 11.5" spacing) from a second batch of joists were carefully selected, with variable locations of knots along their spans. The hypothesis tested was that the location of the weakest point in the joist with respect to the location of the gap in the sheathing plays a key role in the effective bending strength of the joist due to partial composite action (PCA). The T-beams and the bare joists were loaded to failure with the same loading conditions as in the preliminary tests, as shown in Figure 5.

**Figure 5. Second set test setup.**

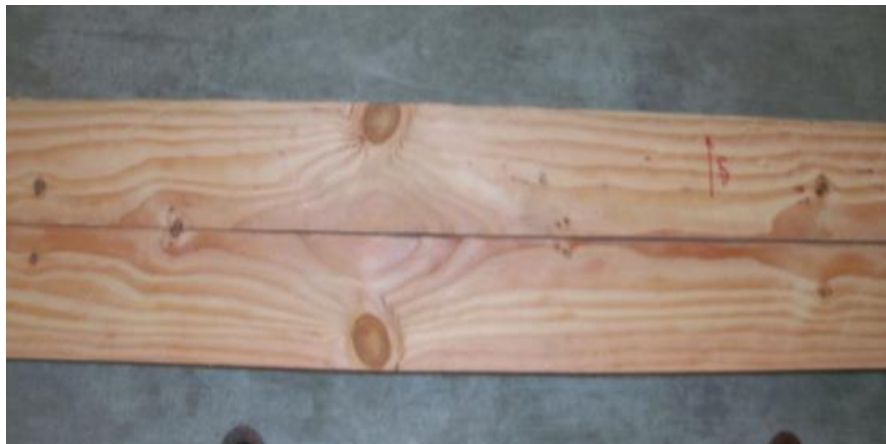
transverse section of the joist. The purpose was to cut the 4"×4" nominal (3.5"×3.5" actual dimensions) joists into two 2"×4" nominal (1.5"×3.5" actual) joists, as shown in Figure 8, to produce the minimum difference in strength as both joists have nearly identical properties.

**Figure 8. Twin 2"×4" joists cut from a single 4"×4" joist.**

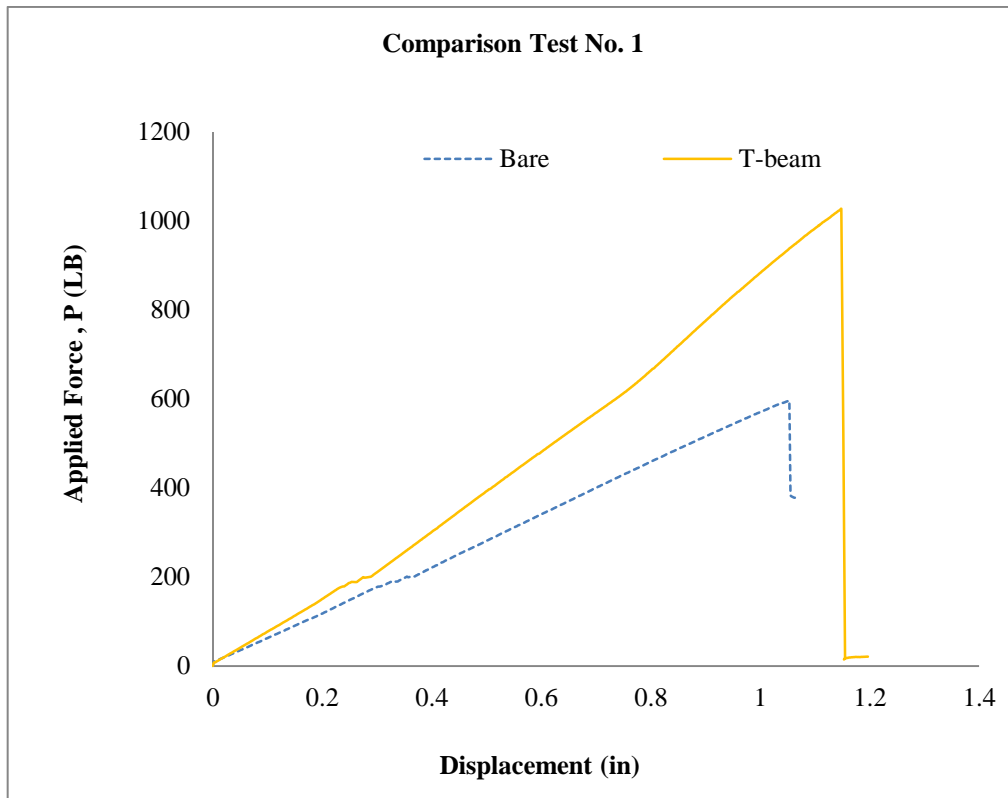
As shown in Figure 10, for each pair of 2"×4" joists, the composite joist was stronger than its noncomposite twin. The load-displacement relations for the twin 2"×4" joists from test No. 1 are shown in Figure 11. An increase in stiffness as well as in strength is evident for the T-beam, compared to the bare joist. The readings from the dial gage at the location of the gap showed that the gap had completely closed when the T-beam reached its bending strength. This closure in the gap means that some continuity of the top flange was present and the OSB began carrying higher compressive forces, and hence, a larger percentage of the total external moment. Note that in all of the previous experiments (with joists with a lower structural grade), the joists failed before the gap could close. The higher the bending strength of the bare joist, the more likely the 1/8" gap is going to close completely, as the T-beam will have a greater curvature and a greater

Figure 11. Load-displacement relations for test No. 1.

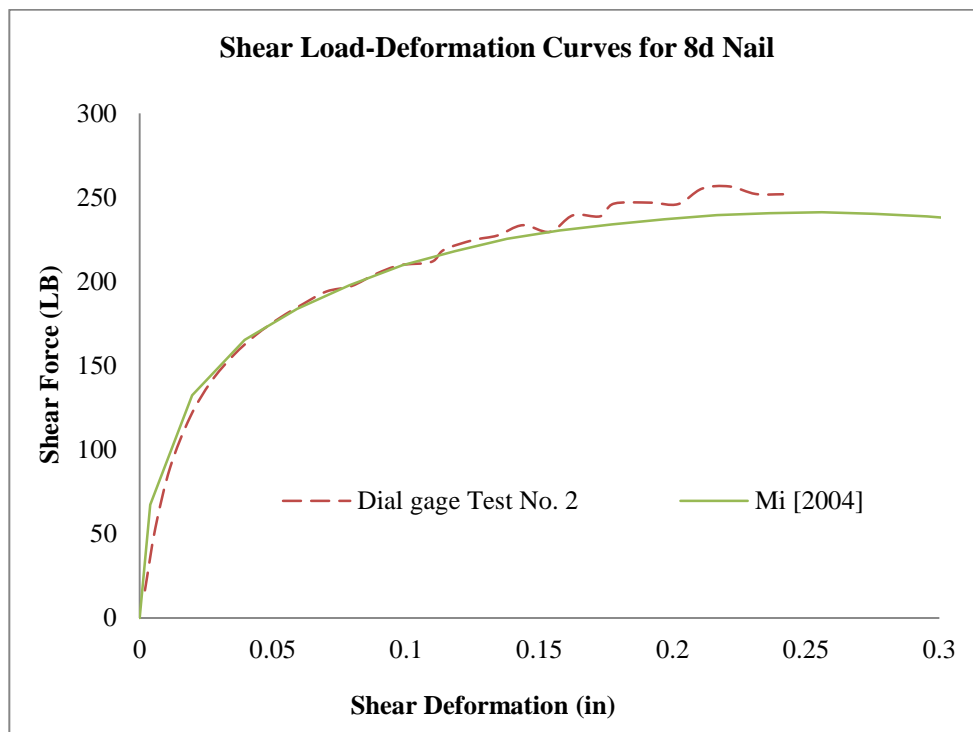
Several researchers have tested joist-to-sheathing connections with different specimen configurations and parameters. Mi (2004) tested ten specimens of spruce pine fir (SPF), connected to 7/16" OSB panels with 8d nails, developing a multilinear model for the shear load-shear displacement relation based on his test results. Mi's test setup was used in this research at constant moisture-content conditions, altering only the species of the lumber (Douglas-fir) with almost the same specific gravity as SPF and loading the specimen in compression rather than in tension. A comparison between the resulting load-displacement relations from the test and the multilinear model developed by Mi, for one nail, is shown in Figure 12. As shown in this figure, the newly-obtained relation follows very closely the relation developed by Mi.

Figure 12. Shear load-deformation of one nail comparison.

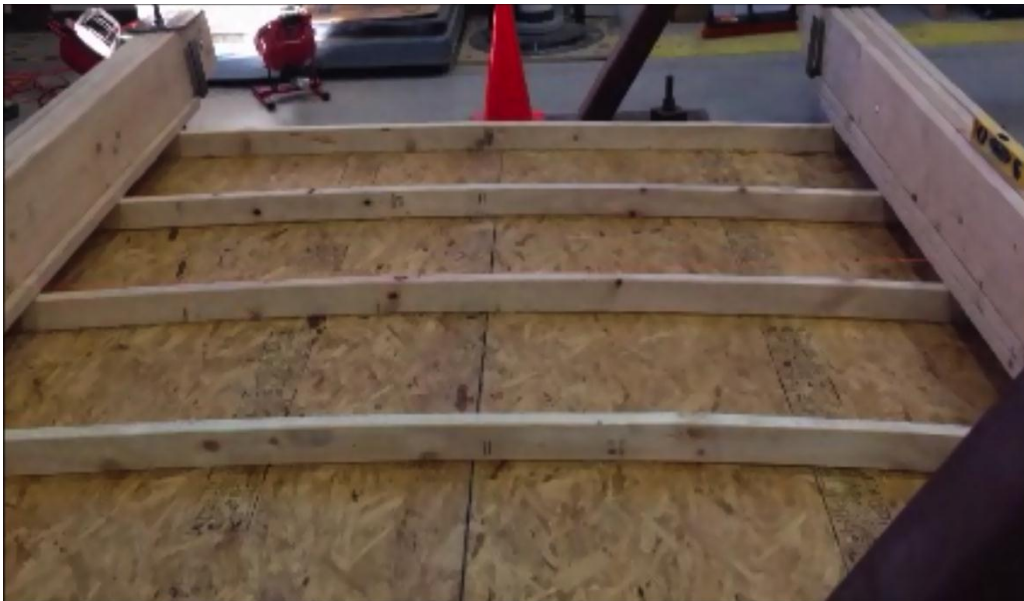
In preparation for a test, the completed assembly was inverted and set on top of the air bladder. The reaction headers were then placed above the assembly. All dimensional lumber and OSB decking was purchased from a local lumber retailer (Home Depot). Figure 15 provides a photograph of a roof assembly under load.

**Figure 15. Photograph of roof assembly under load.**

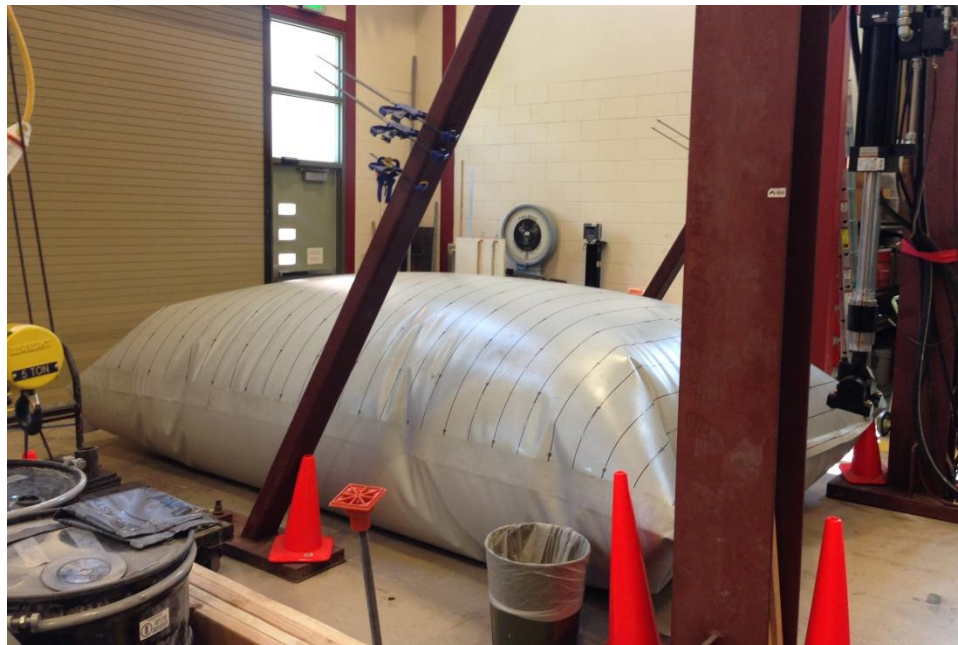
Air bladders were custom built for each test assembly plan area using 40 mil polyvinyl chloride (PVC) sheets glued together with PVC adhesive. Figures 16 and 17 show photographs of two of the PVC air bladders used.

**Figure 16. Photograph of the 10'×16' PVC air bladder.**

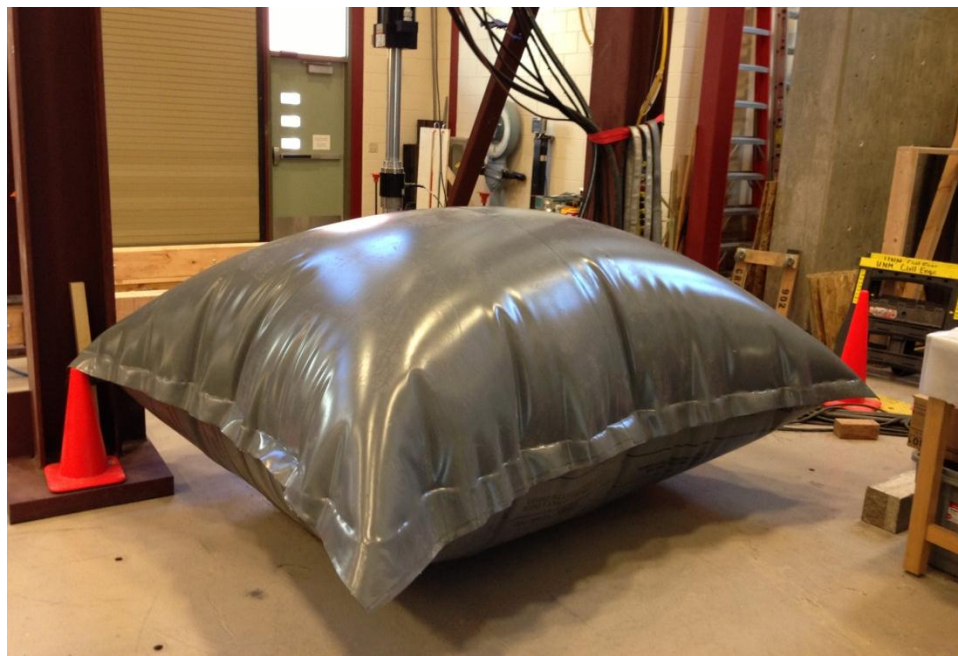
**Figure 17. Photograph of the 8'×10' PVC air bladder.**

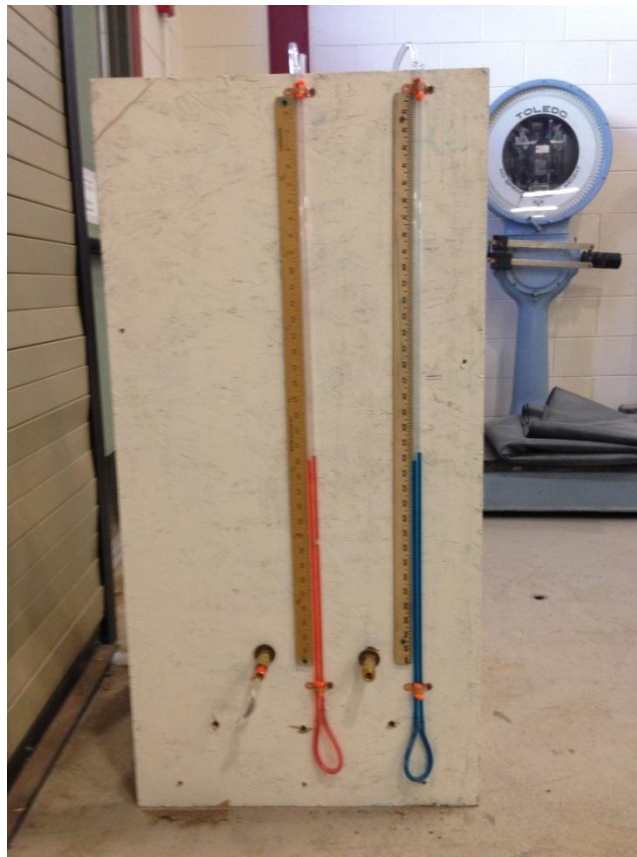
During air bladder inflation, pressure was monitored using water column manometers as shown in Figures 19 and 20.

**Figure 20. Photograph of double manometer used in laboratory.**

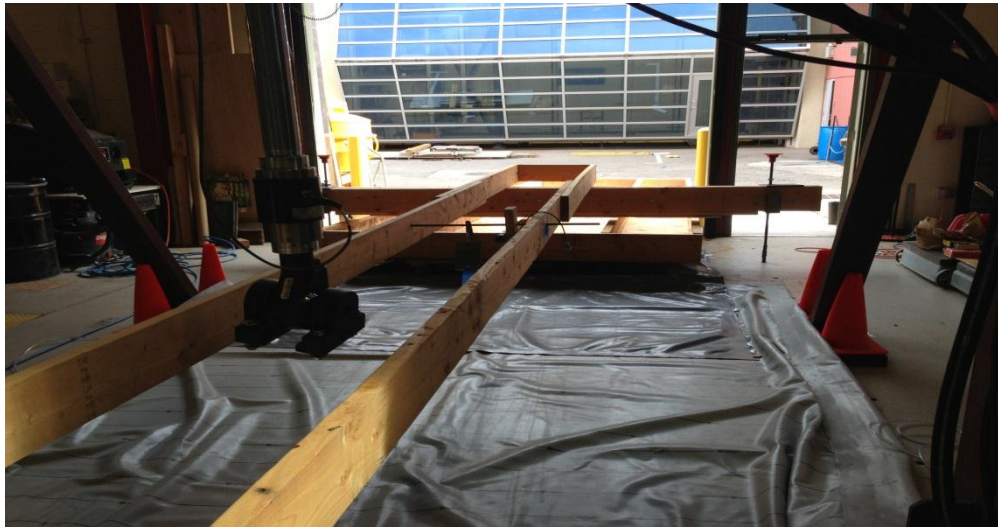
For each test, reaction headers were set at the appropriate distance to accommodate the chosen span. After the reaction headers were in place, the assembled inverted roof panel was moved, using rolling dollies, into testing position above the bladder and below the reaction headers. Next, the test assembly was clamped to the headers suspending it above the bladder to allow for perfect bladder inflation. Figure 23 is a photograph of an assembly being rolled under the reaction headers.

**Figure 23. Photograph of assembly being rolled onto air bladder.**

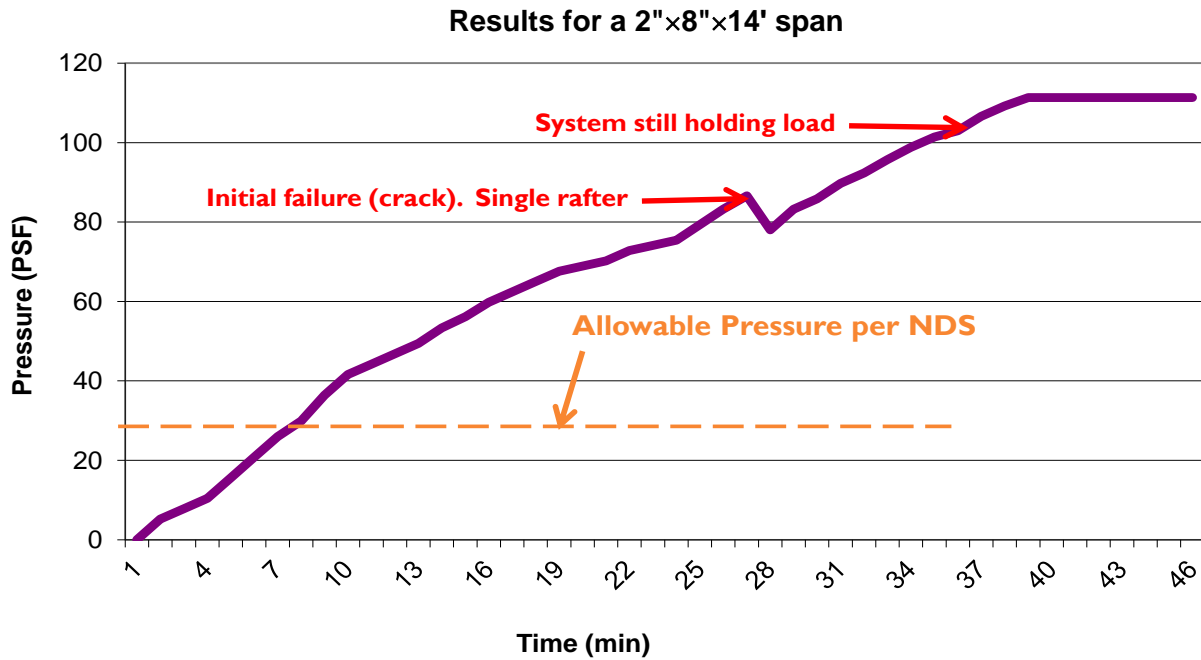
A typical failure load curve can be seen in Figure 24. Failure of the first structural member allows for a decrease in pressure and thus identifies failure for the test assembly. It can be seen however, that failure of the initial structural member does not necessarily constitute system failure. The roof assembly generally would allow for pressure buildup well beyond the initial failure point. The team generally stopped a test when the deflection became too large for the test apparatus.

**Figure 24. Typical failure curve for roof assembly.**

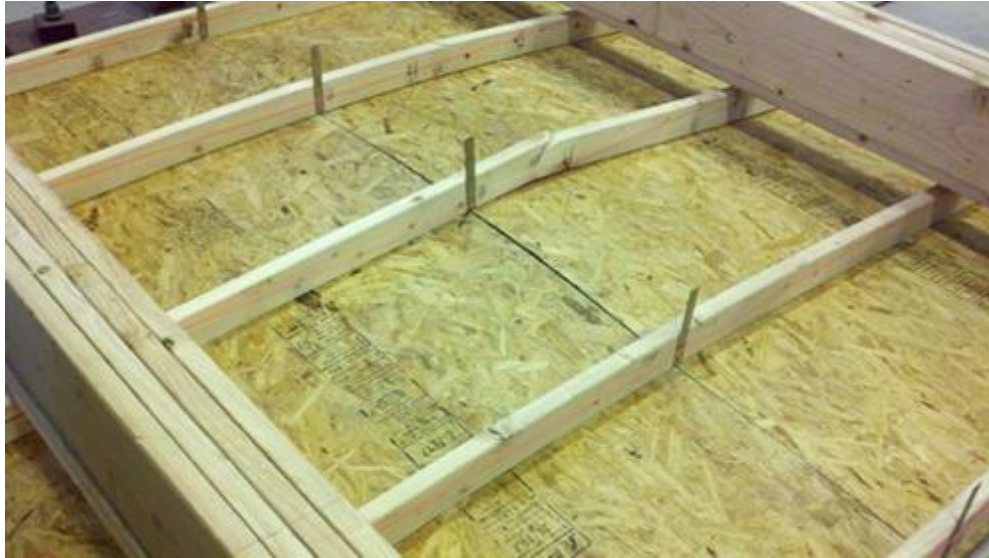
Typical member failures during testing are shown in Figures 25 and 26.

**Figure 25. Typical failure in rafter, most occurred in center.**

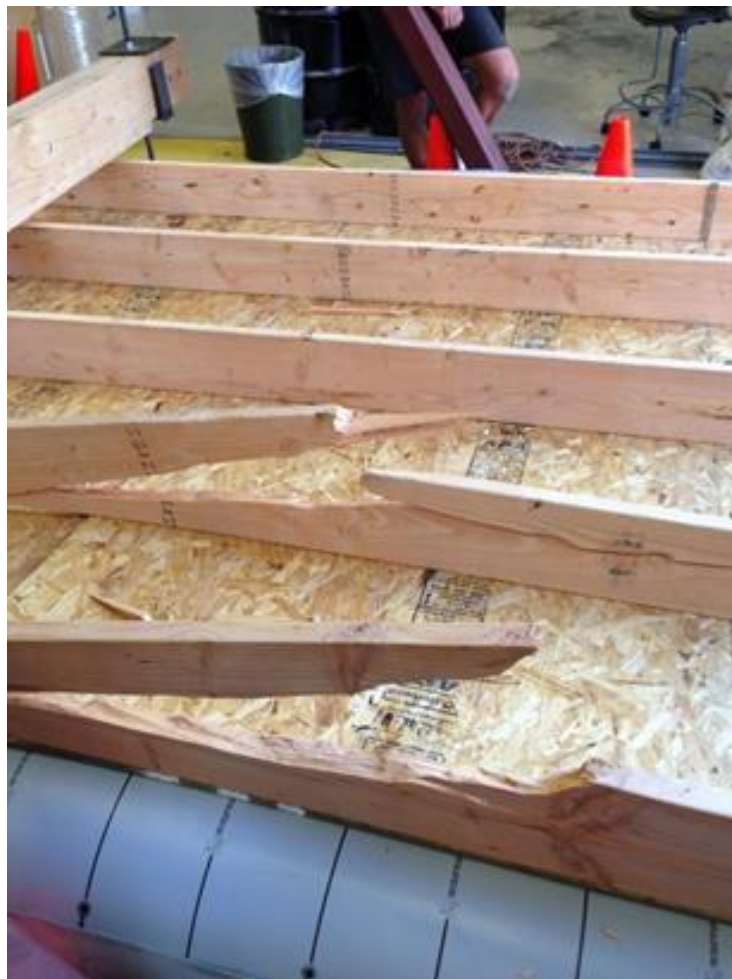
**Figure 26. Failure in rafter, some occurred in side rafters.**

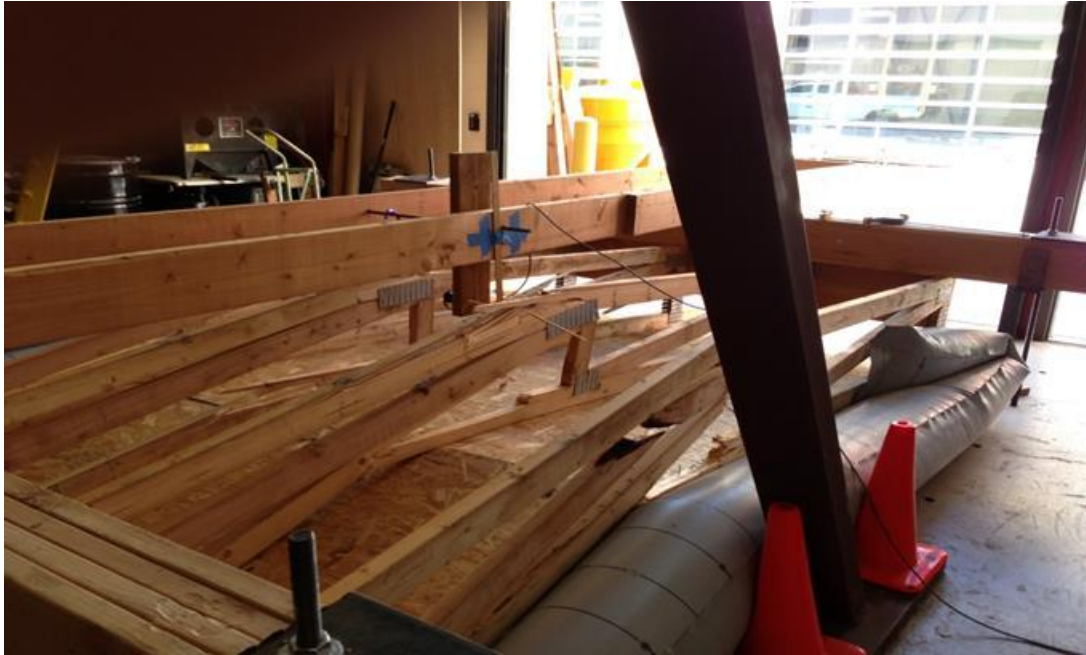
Failure in open-web trusses occurred in truss members (Figure 27) as well as joint connections (Figure 28). Failure produced an immediate, system-wide, permanent loss in load-carrying capacity.

**Figure 27. Failure in open web (web member) truss roof test assembly.**

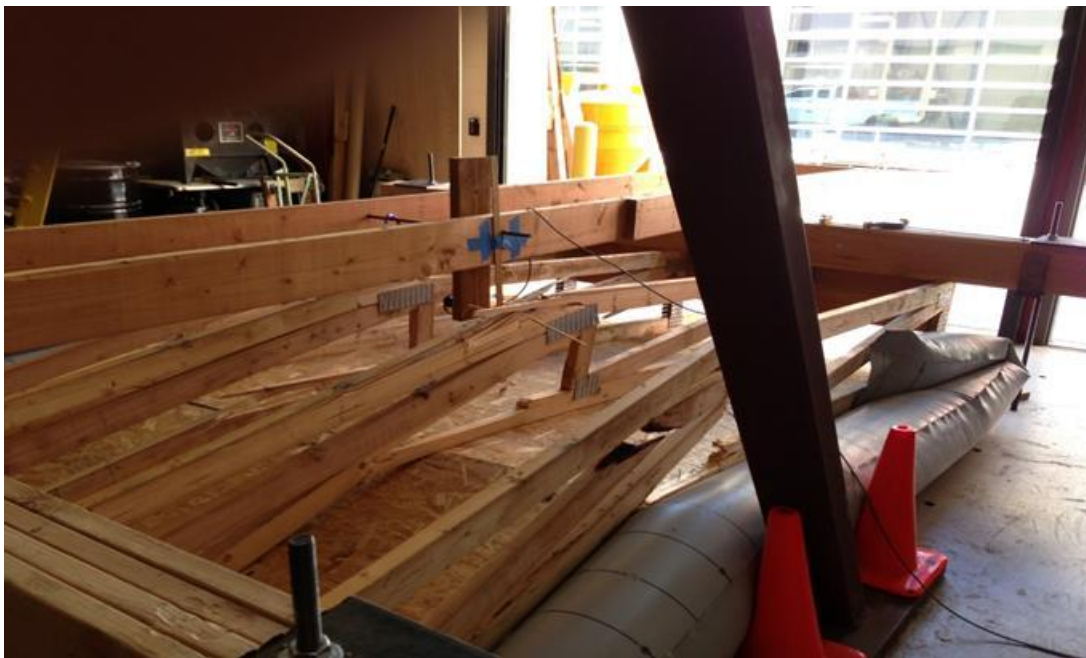
**Figure 28. Failure in open web (member connection) truss roof test assembly.**

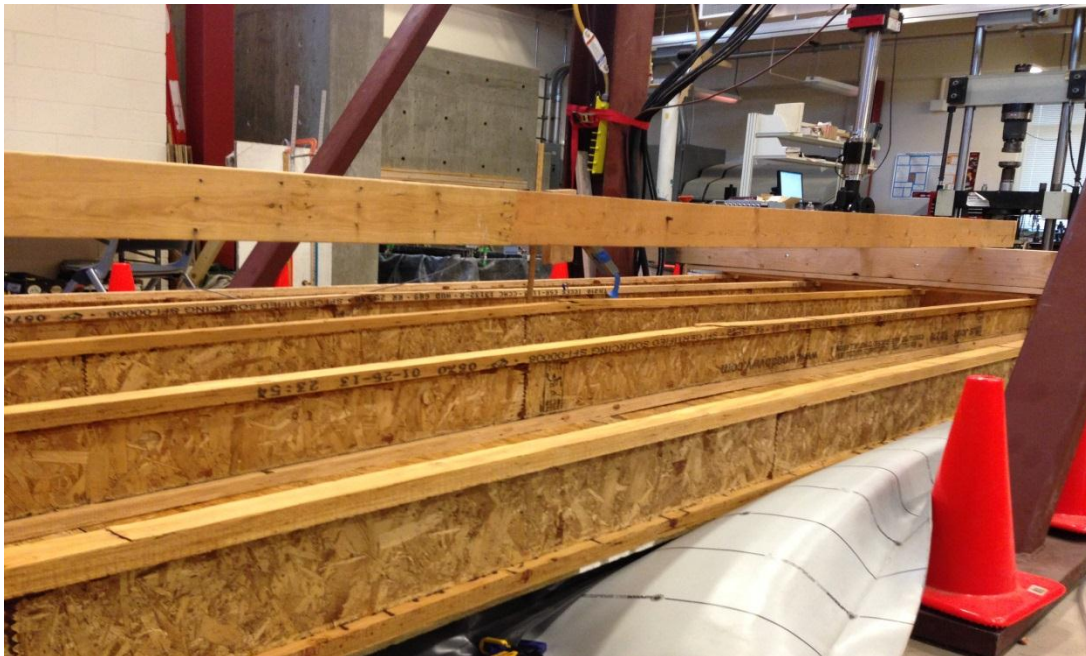
Trus Joist (TJI) is the company that developed the wooden I-joist 50 years ago. The product is a fabricated wooden joist engineered to provide strength and stability. The I-joist is lightweight and available in long span lengths. A series of tests featuring TJIs were performed similar to the dimensional lumber testing. The failure mode was very consistent in that the top chord generally failed first. Furthermore, the beam strength is very consistent (Table 5). During several of the tests the top chord of multiple TJIs failed simultaneously (Figure 29).

**Figure 29. Failure in TJI roof test assembly.**
