Middle Rio Grande (MRG) Municipal Separate Storm Sewer System (MS4) Permit

*Stormwater Quality Program
Environmental Compliance and Monitoring
October 29, 2024*

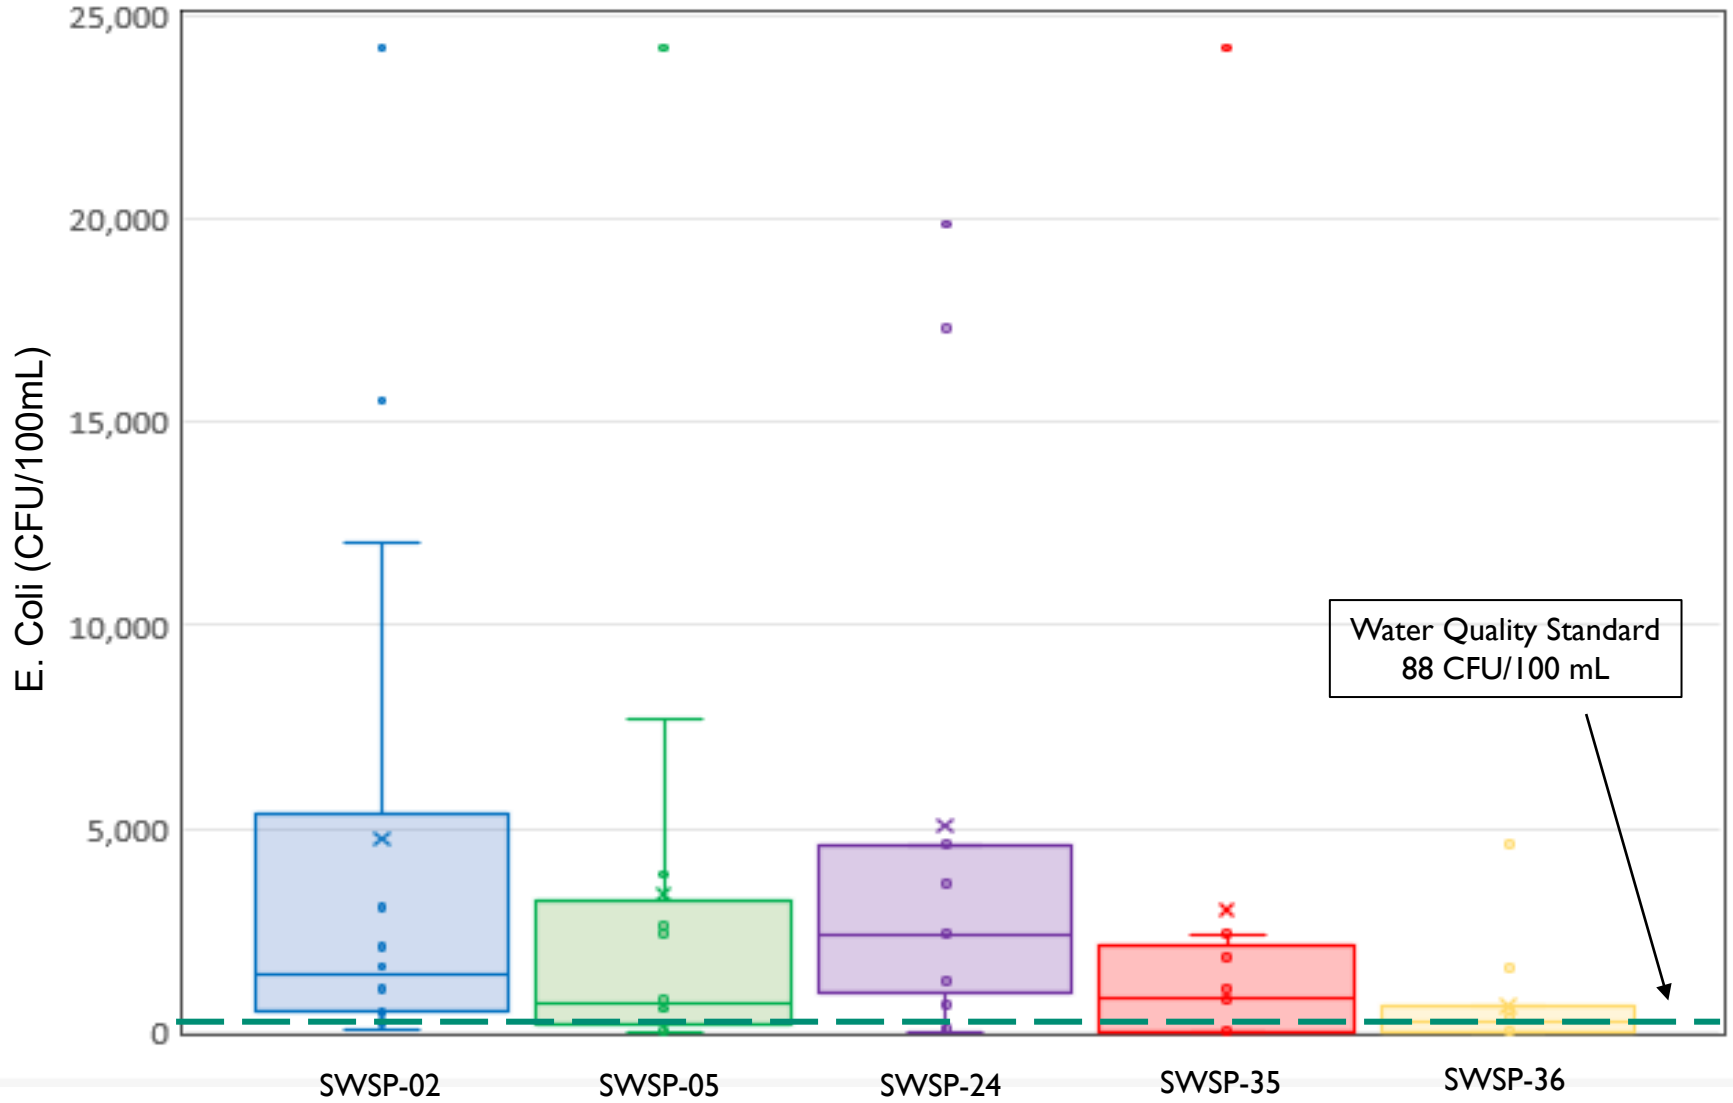
MS4 E. Coli Samples by Location (2016-2024)

SWSP-02 SWSP-05 SWSP-24 SWSP-35 SWSP-36

Water Quality Standard
88 CFU/100 mL

- Microbial Source Tracking Study (2020)
 - No E. coli from human sources
 - No E. coli from canine sources, low avian contribution
 - Suspect primary source is skunks, racoons, rodents
- Coordination with the Ecology Program reducing wildlife attractants and access to stormdrains
 - Wildlife proof trash cans
 - Barriers to stormdrains
- Coordination with Facilities group to reduce sediment load and standing water in stormdrains
 - Have seen significant improvements in the area of SWSP-02 since 2022

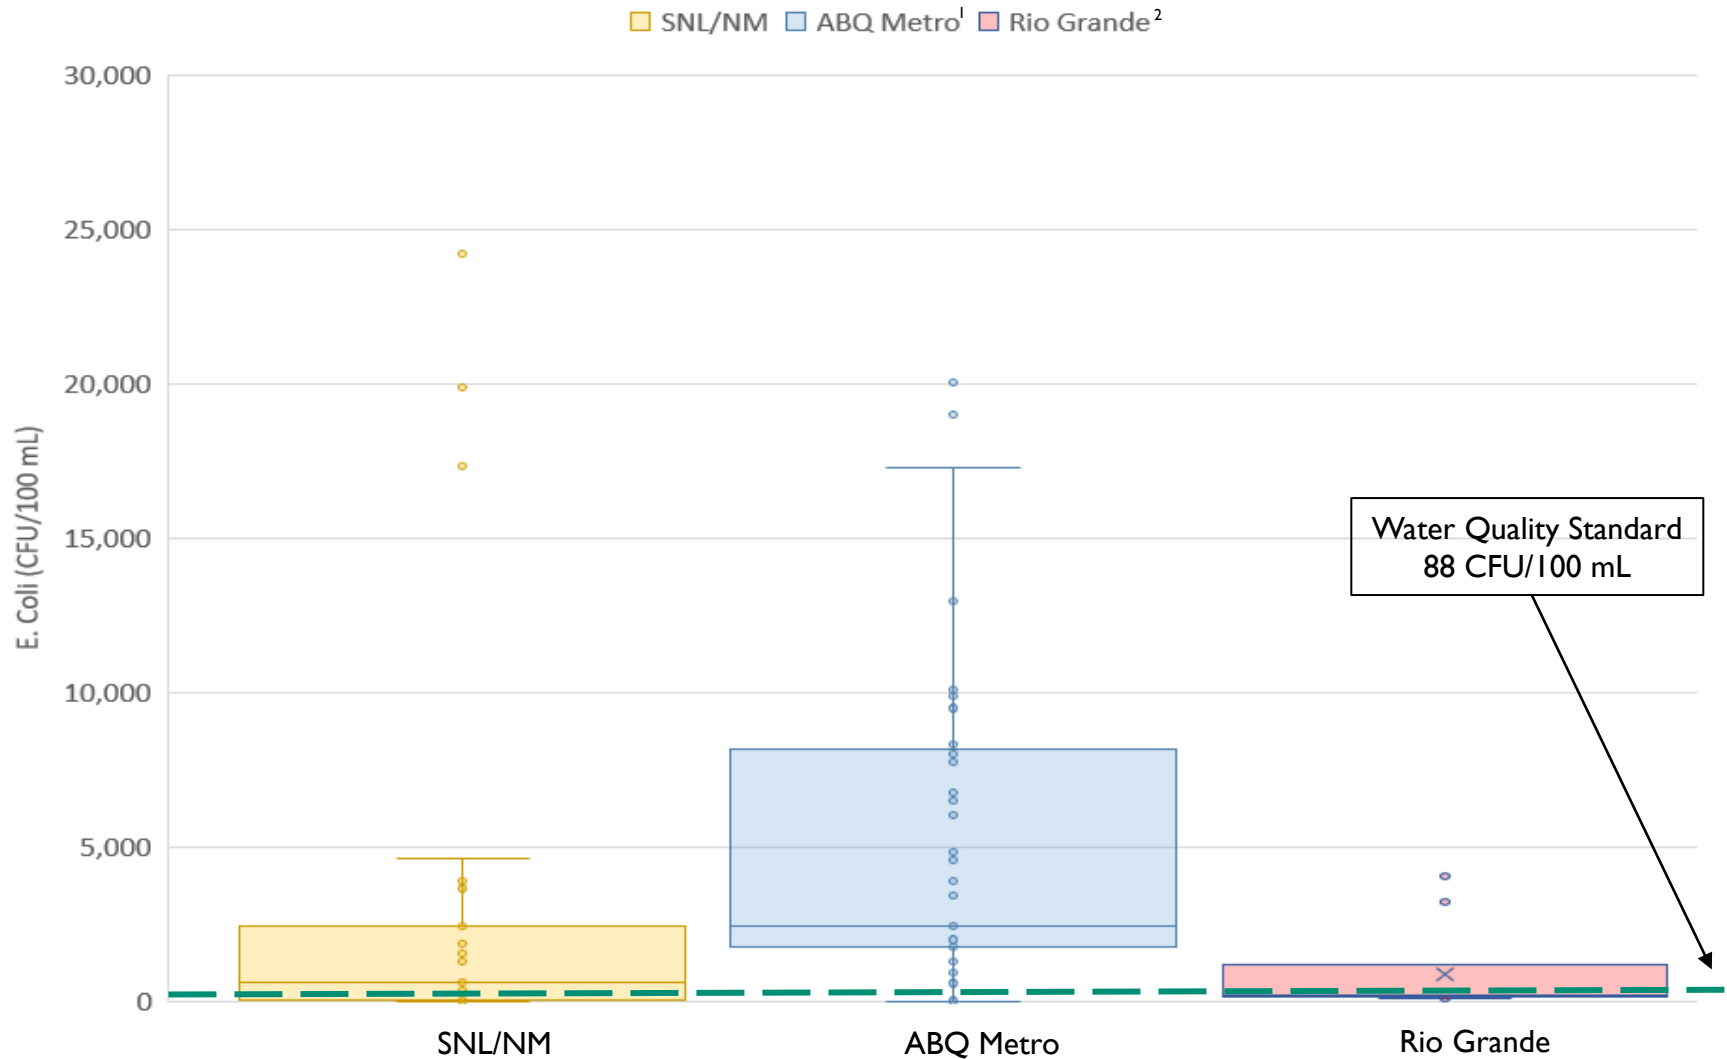
E. Coli in the Albuquerque Metropolitan Area

- 1 U.S. Geological Survey, Scientific Investigations Report 2015-5006. Summary of Urban Stormwater Quality in Albuquerque, NM 2003-2012. 2015.
- 2 https://www.usgs.gov/centers/nm-water/science/microbial-source-tracking-and-escherichia-coli-monitoring-rio-grande-south?qt-science_center_objects=0#qt-science_center_objects.

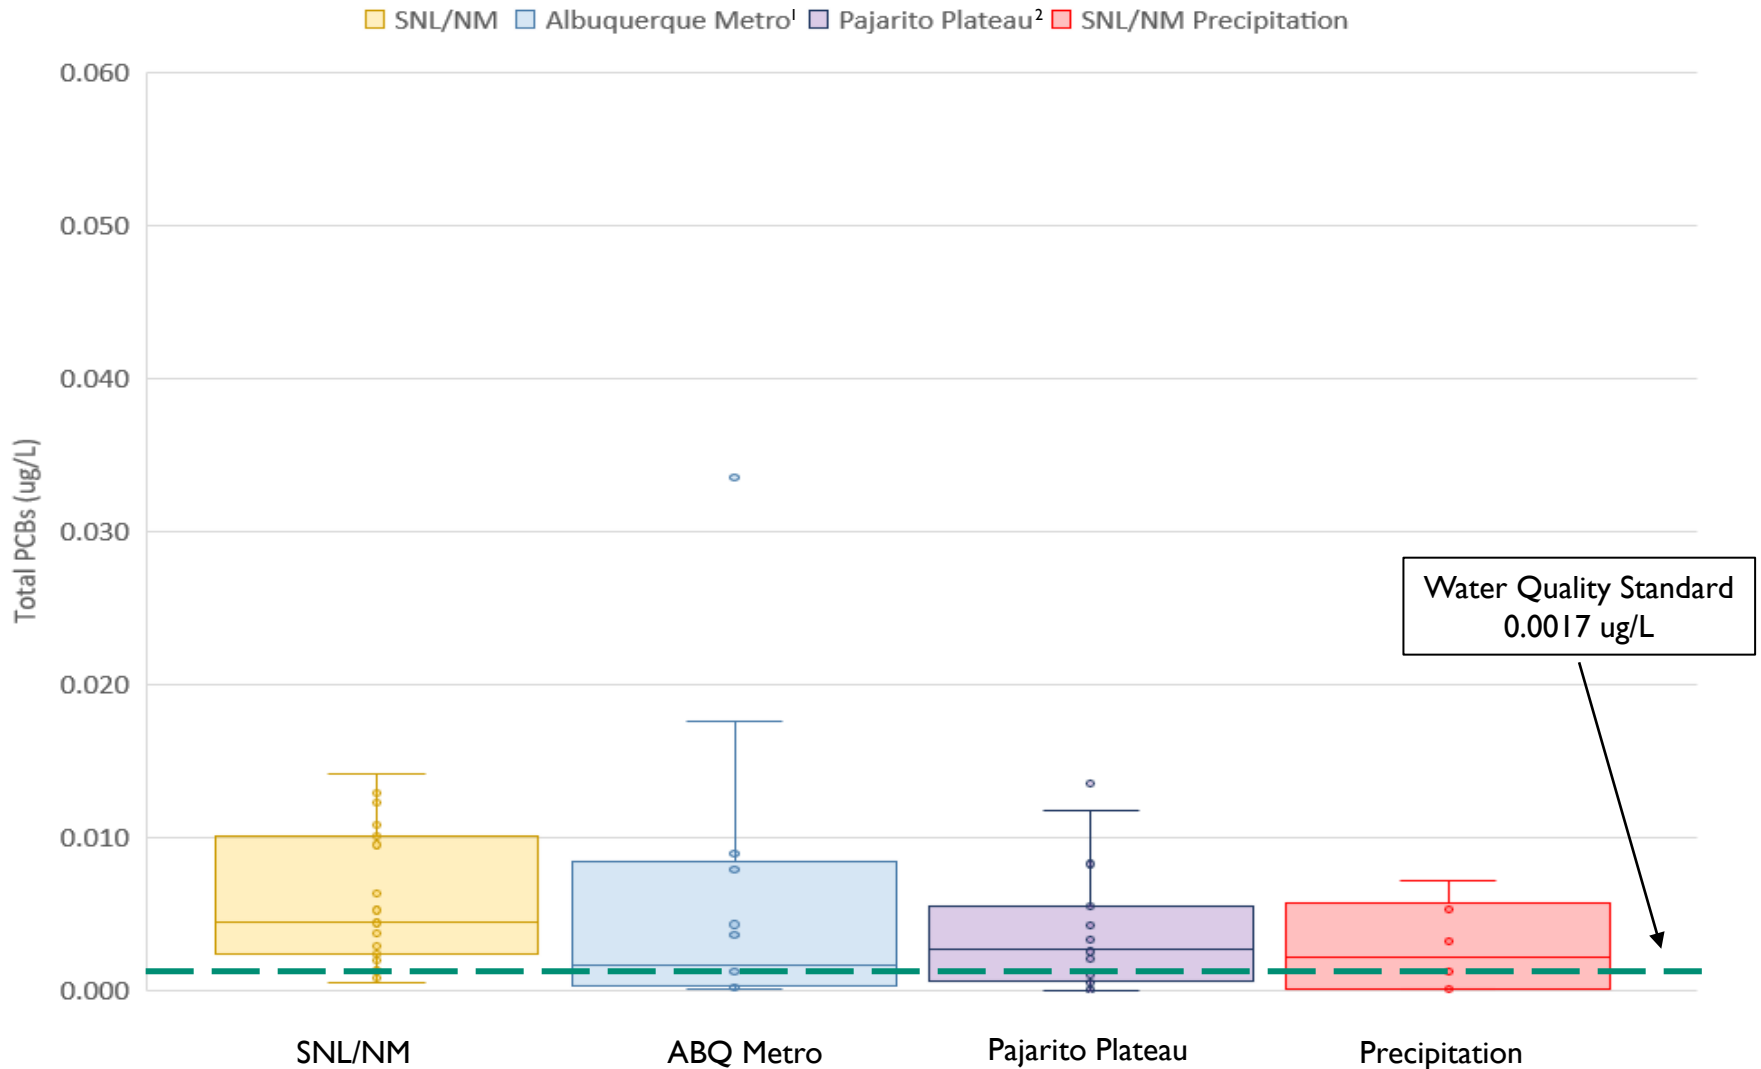
PCBs at Various NM Locations

1 U.S. Geological Survey, Scientific Investigations Report 2015-5006. Summary of Urban Stormwater Quality in Albuquerque, NM 2003-2012. 2015

2 Los Alamos National Laboratory. LA-UR-12-1081. PCBs in Precipitation and Stormwater Within the Upper Rio Grande Watershed. 2012
